**FLARE LINE FAILURE CASE,  
WHAT HAVE WE LEARNED?**

Abram Kuo  
Ryan Pitt  
Westlake Group  
900 Hwy 108  
Sulphur, LA 70664

Prepared for Presentation at the 2004 Spring  
National Meeting, New Orleans, LA  
April 25-29  
16<sup>th</sup> Annual Ethylene Producers' Conference  
Session T8001 – Ethylene Plant Safety

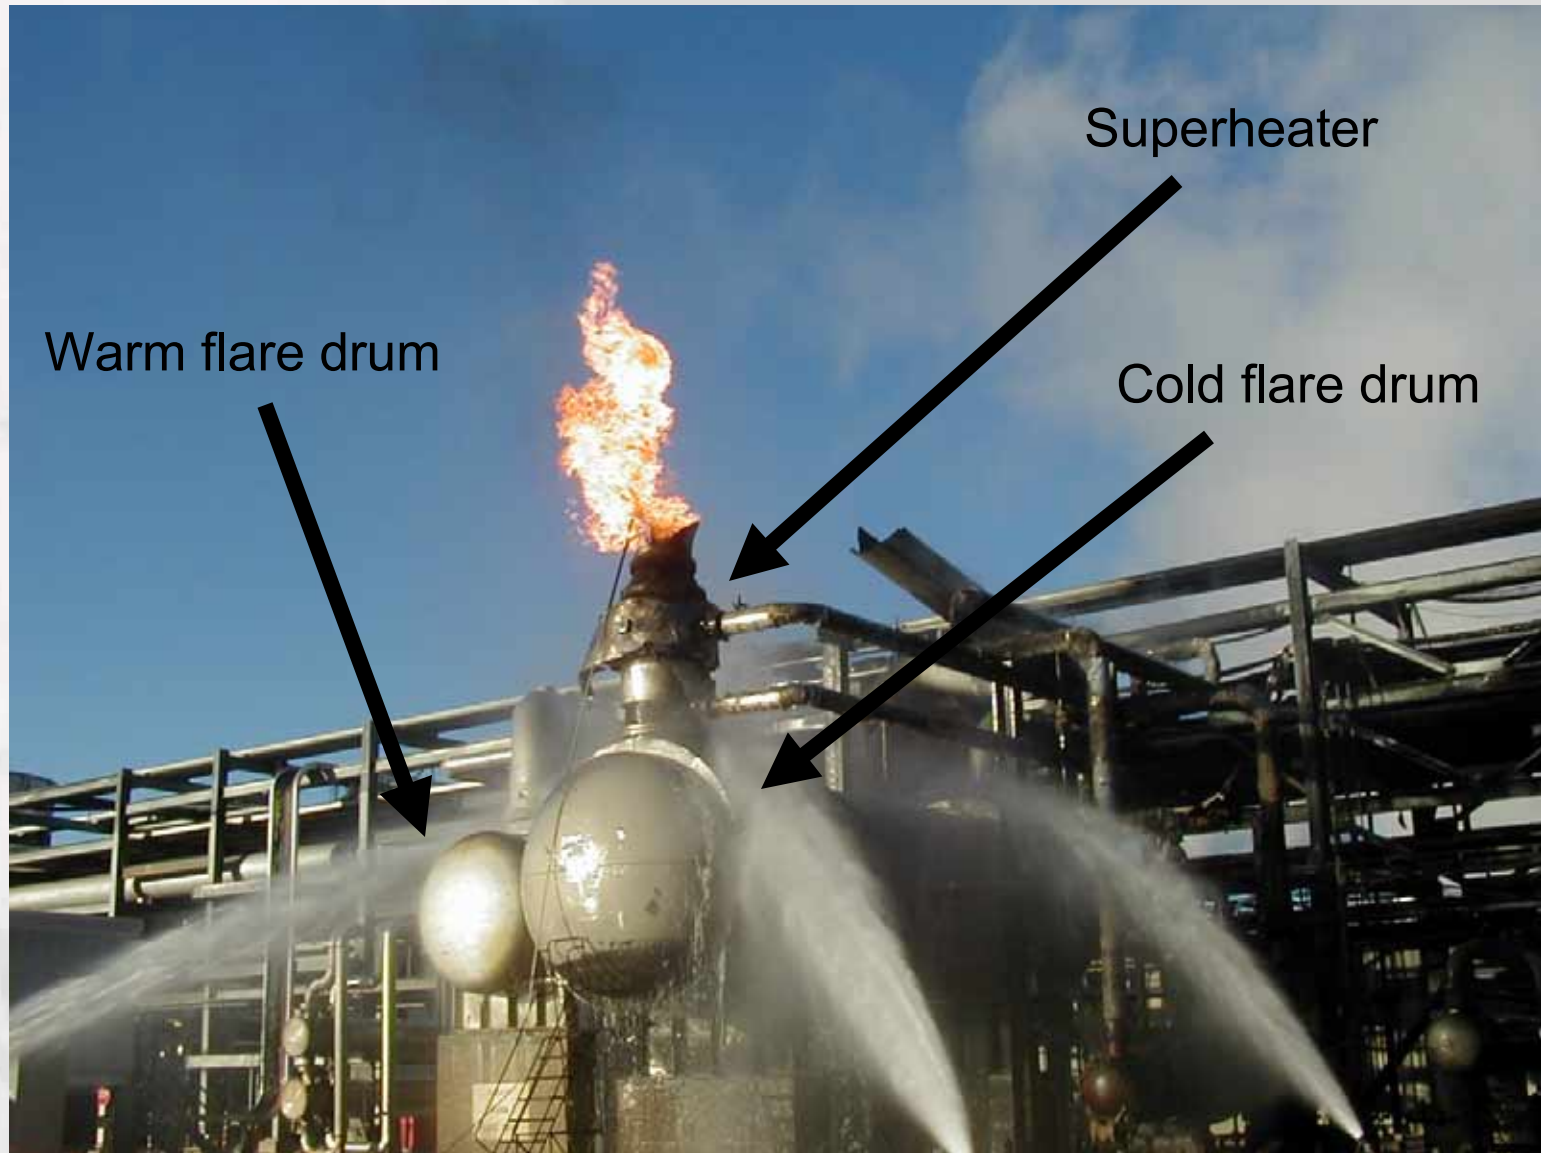
# Cold Flare Drum Overhead Line Fire

- A low temperature alarm sounded as the overhead line temperature fell to 0 F, and the thermocouple “went bad” at a value of -13 F
- With the cold flare drum overhead line running below its minimum design temperature of -10 F, the pipe ruptured, resulting in loss of hydrocarbon containment
- The hydrocarbon released found an ignition source, resulting in an explosion and fire

- Vaporizer/superheater exchanger fouling had reduced heat transfer capacity of the cold flare system
- Once flaring began, the cold flare drum overhead line experienced low temperature
- Brittle fracture of cold flare drum overhead piping due to operation below the minimum design temperature of the carbon steel line

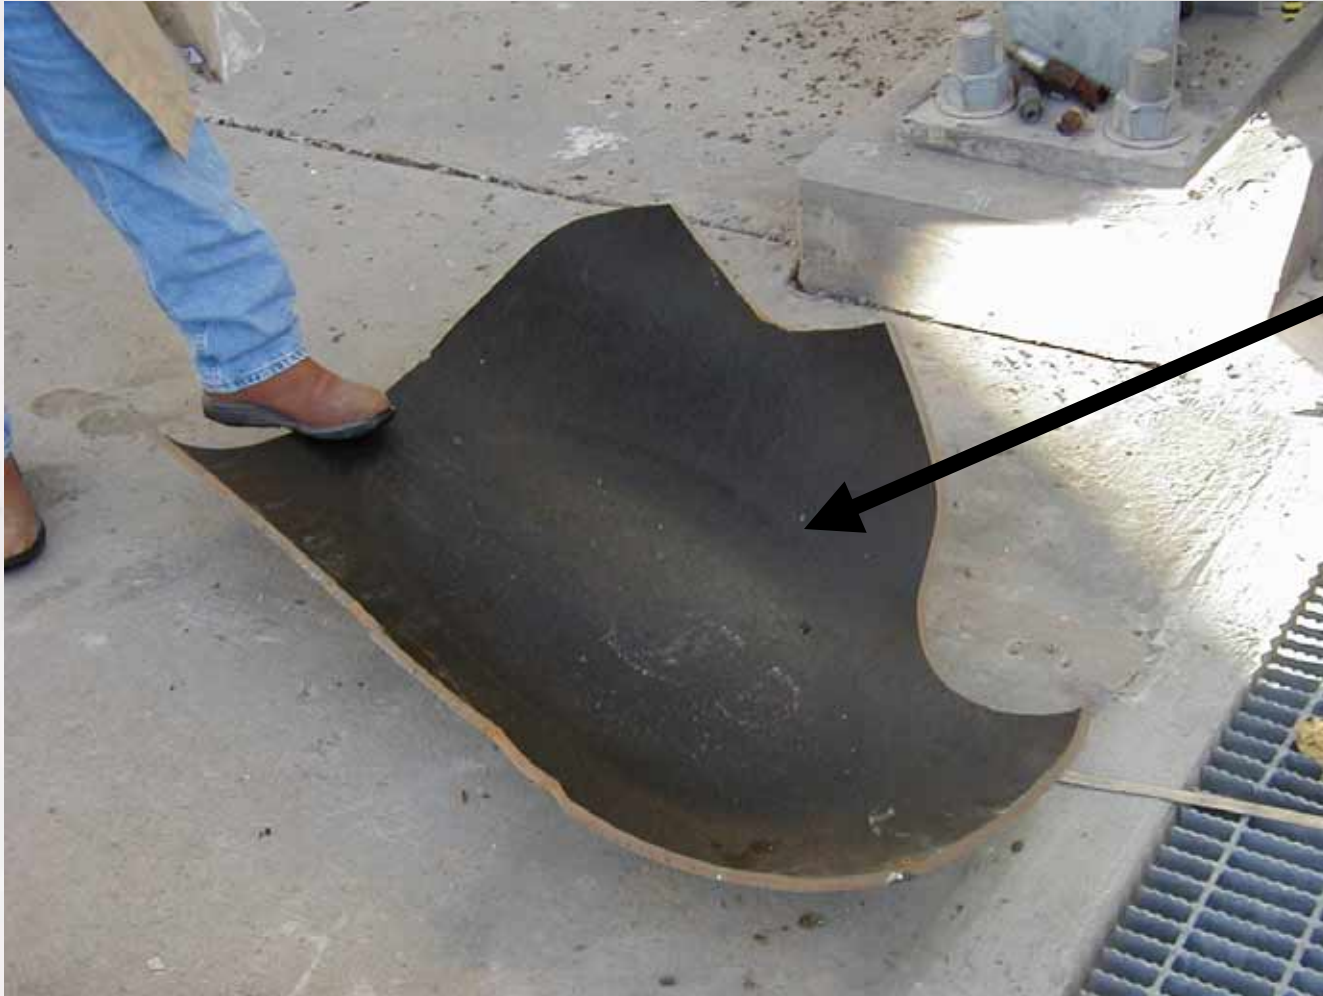
# Overhead Line Brittle Fracture

- The “final stress” that ultimately caused the brittle fracture of the piping has not been identified, but could have been any number of internal or external stresses
- External stress - Hard rain that came at the time of event?
- Internal stress - Contraction of the cold flare line due to temperature gradient?

30" cold flare  
drum  
overhead line  
failure due to  
brittle fracture

- Carbon steel piping is typically used in services w/ temperatures above -10 to -20 F
  - Impact testing can certify the use of carbon steel piping in services as cold as -55 F (i.e. “killed carbon steel”)
- At temperatures below -10 to -20 F normal carbon steel loses ductility and strength
  - The metal becomes brittle and can be susceptible to brittle fracture
- Three main factors influence the onset of brittle fracture:
  - Temperature
  - Flaw size (notches, scratches, etc...)
  - Stress

- Carbon steel flare system piping replaced with stainless steel, ~100' downstream of warm/cold flare drum tie-point
- Thermocouple installed on new stainless steel piping upstream of SS to CS transition
- Stress analysis on the new flare line, FEA on flare drum
- See “Flare Drum System Modifications” diagram
