**FLARE LINE FAILURE CASE,
WHAT HAVE WE LEARNED?**

Abram Kuo
Ryan Pitt
Westlake Group
900 Hwy 108
Sulphur, LA 70664

Prepared for Presentation at the 2004 Spring
National Meeting, New Orleans, LA
April 25-29
16th Annual Ethylene Producers' Conference
Session T8001 – Ethylene Plant Safety

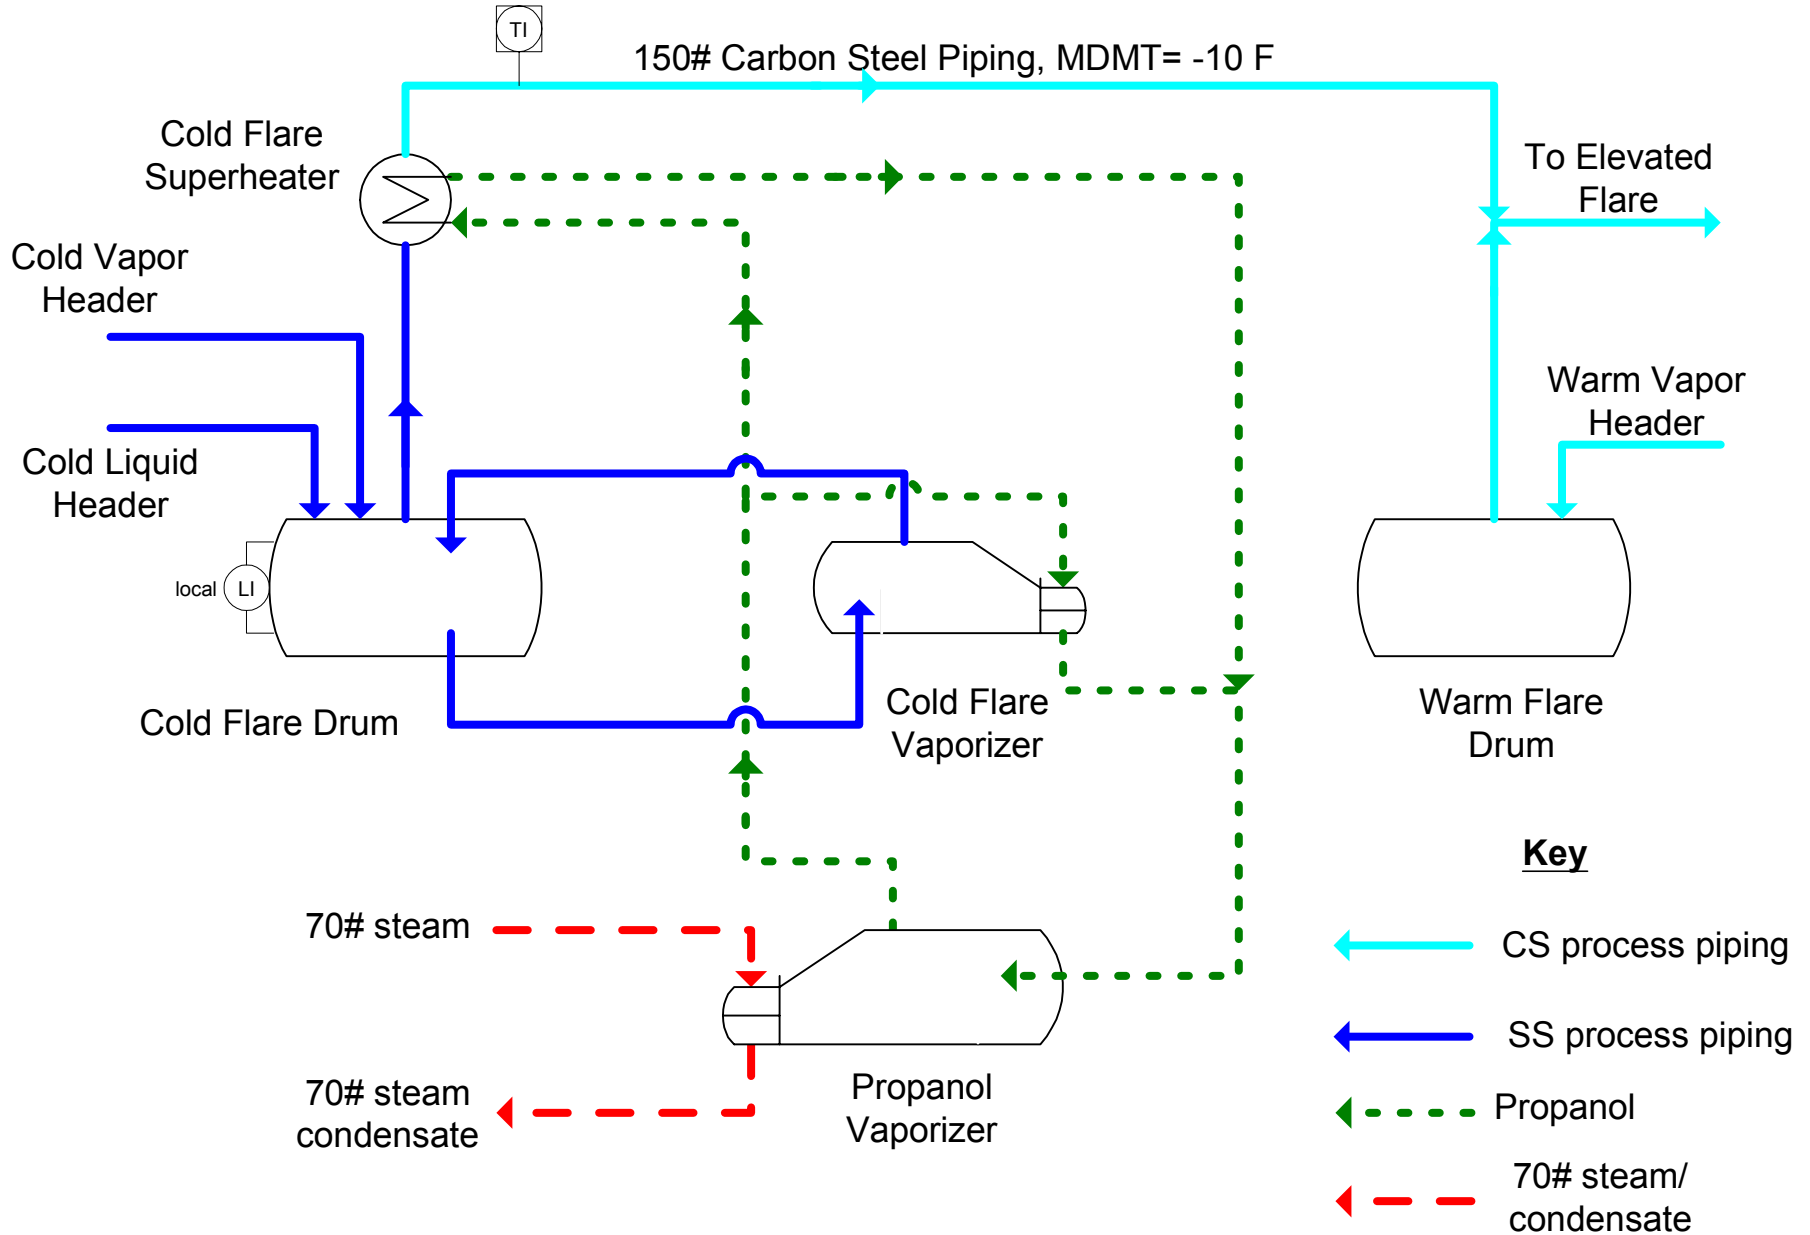
Original System

- The cold flare drum contents are vaporized and superheated with a closed loop propanol system
- Heat is supplied to the propanol system with 70# steam (~270 F)
- The vaporizer and superheater heats the cold flare drum material from cryogenic temperatures to above the minimum design metal temperature of the cold flare drum carbon steel overhead piping @ -10 F

- After the event, it was determined that fouling had compromised the operation of the vaporizer and superheater exchangers

- 2 LI's installed on cold flare drum w/ DCS hi alarms @ 10%
- Heavy oil pull down system installed to allow removal of heavy oil from the cold flare drum
- Cold flare drum superheater replaced with 50% larger exchanger and propanol piping was replaced to handle higher throughput

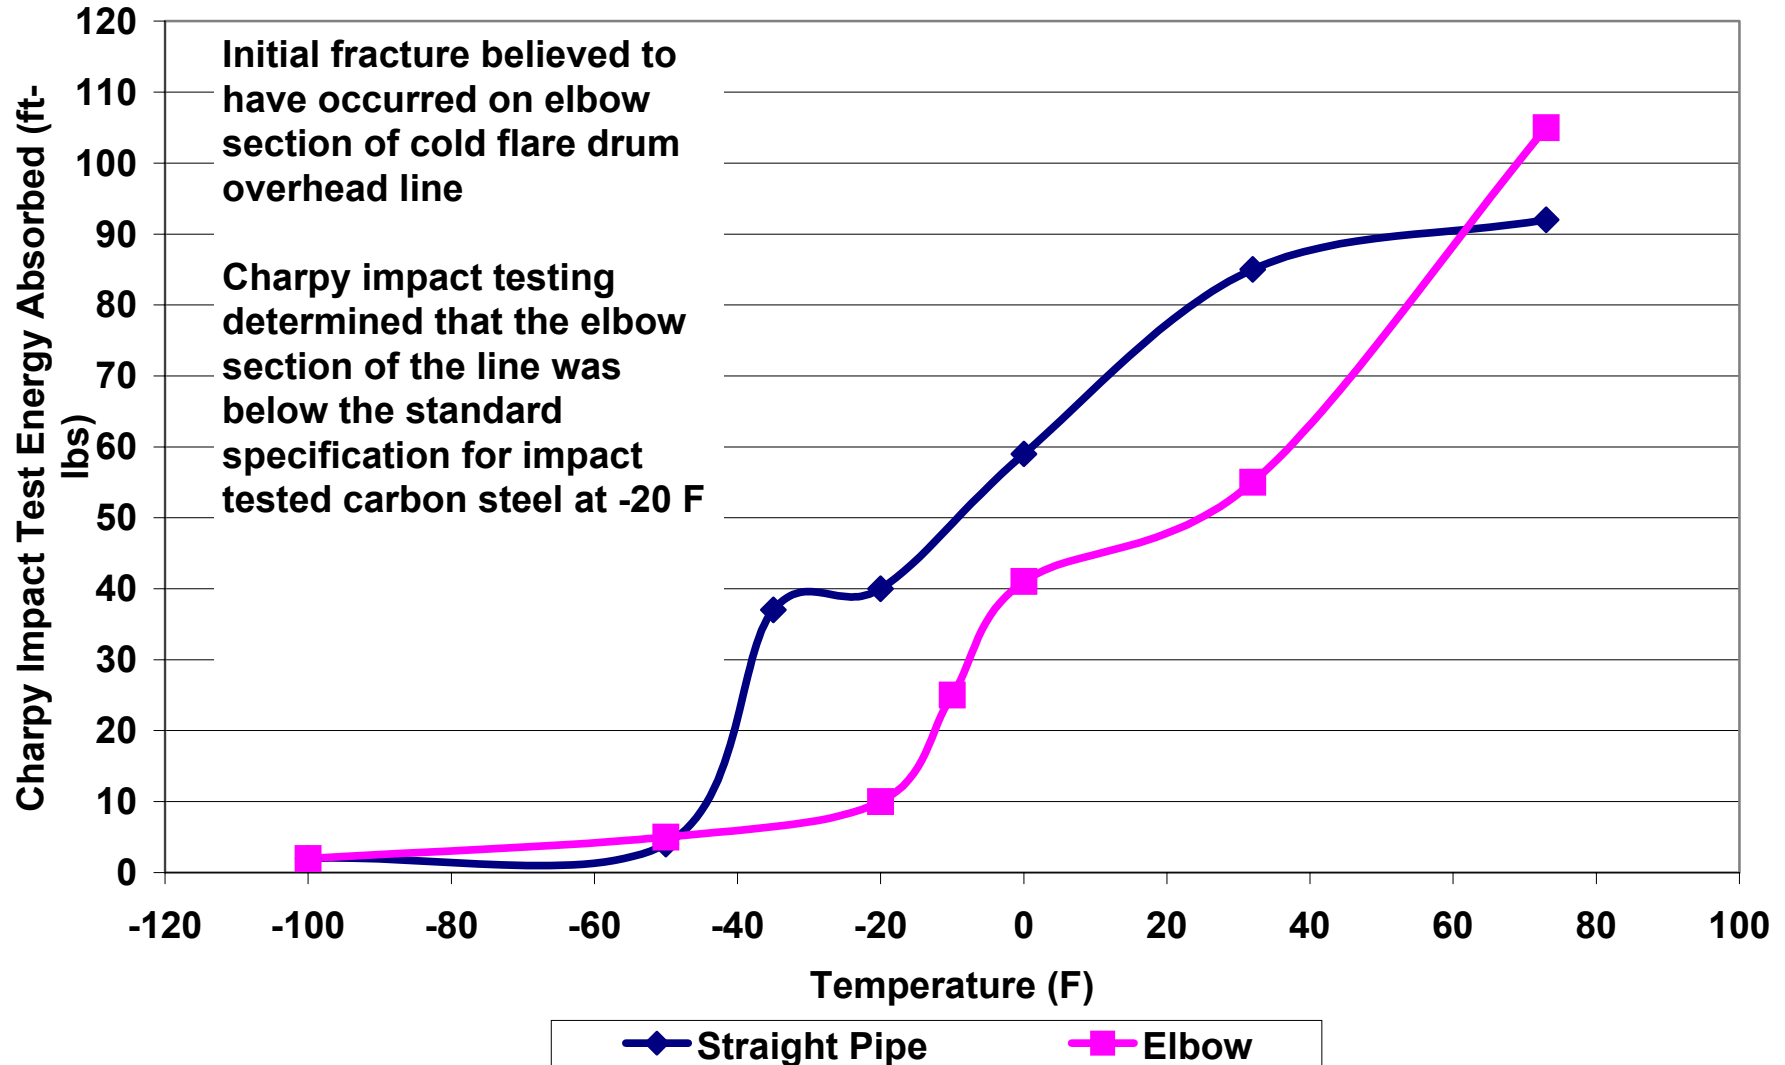
Westlake Charpy Impact Testing on Cold Flare Drum Overhead Line

- Carbon steel piping is typically used in services w/ temperatures above -10 to -20 F
 - Impact testing can certify the use of carbon steel piping in services as cold as -55 F (i.e. “killed carbon steel”)
- At temperatures below -10 to -20 F normal carbon steel loses ductility and strength
 - The metal becomes brittle and can be susceptible to brittle fracture
- Three main factors influence the onset of brittle fracture:
 - Temperature
 - Flaw size (notches, scratches, etc...)
 - Stress
