Design Guidelines for Safety in Piping Networks

Karl Kolmetz
KLM Technology Group

Introduction

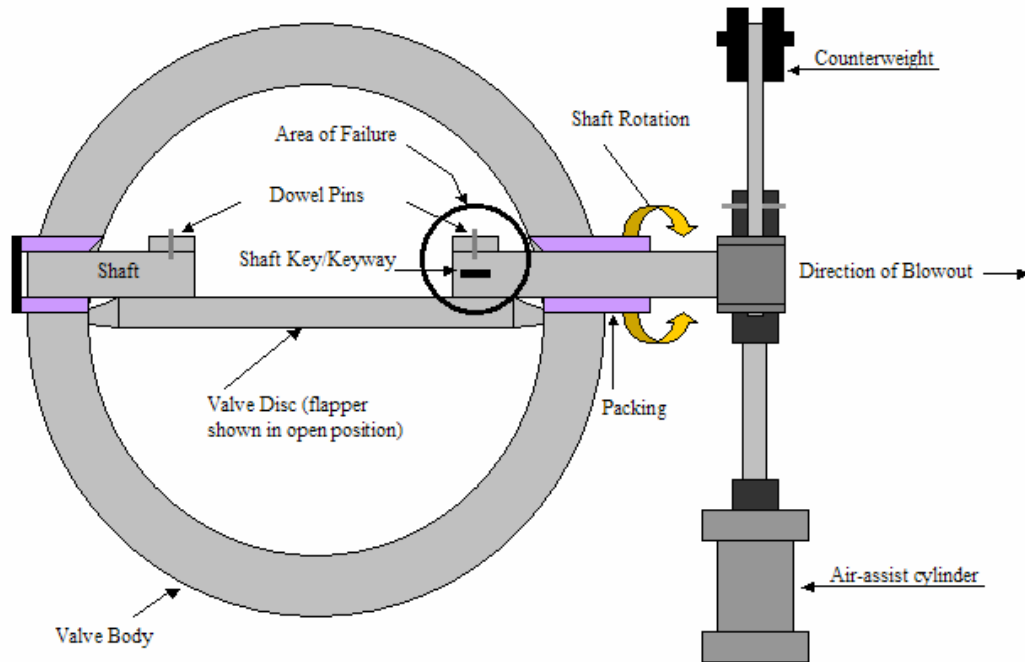
Simplified cross-sectional view of check valve (flow direction is into page)

During this period, the check valves installed in the propane refrigeration compression system slammed closed repeatedly. The shaft of the compressor's third stage discharge valve eventually separated from its disk and was partially ejected from the valve. The shaft was not fully ejected because its path was blocked by an adjacent steam line inches away from the valve, keeping about 70 mm of the shaft's length within the valve body.

A subsequent investigation and analysis of the check valve's internal components revealed that the dowel pin, which secured the drive shaft to the valve flapper, had sheared, and the shaft key had fallen out of its key-way. The investigation report also revealed that facility maintenance records indicated a long history of problems with the check valves installed there. The valves were installed in 1982, and due to continuing

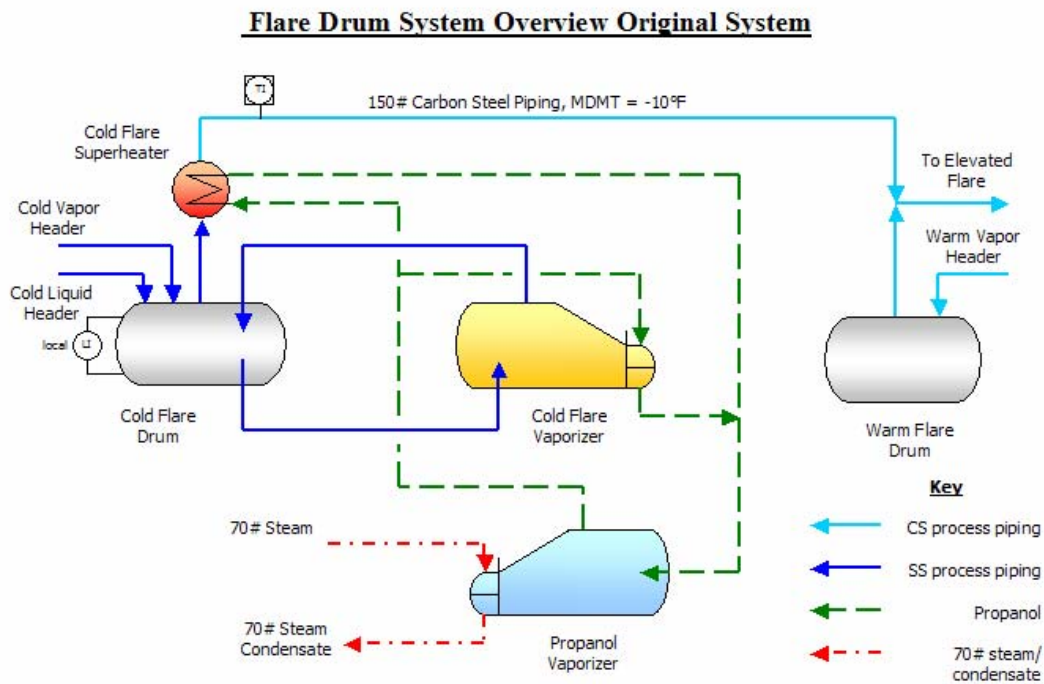
The cold flare drum contents are vaporized and superheated with a closed loop propanol system. Heat is supplied to the propanol system with 70-pound steam, which is about 270 F. The vaporizer and super heater heats the cold flare drum material from cryogenic temperatures to above the minimum design metal temperature of the cold flare drum carbon steel overhead piping.

The event sequence was the ethylene product went off specification on acetylene and initiating flaring of liquid ethylene product began. The acetylene converter outlet analyzer was in error, which allowed the ethylene splitter inventory to be contaminated with acetylene prior to corrective action being taken. A portion of the off spec liquid ethylene product was consumed by internal customers, with the balance being flared via the cold flare drum. Malfunction of the cold flare drum vaporizer and super heater allowed the cold flare drum overhead line temperature to fall sharply.

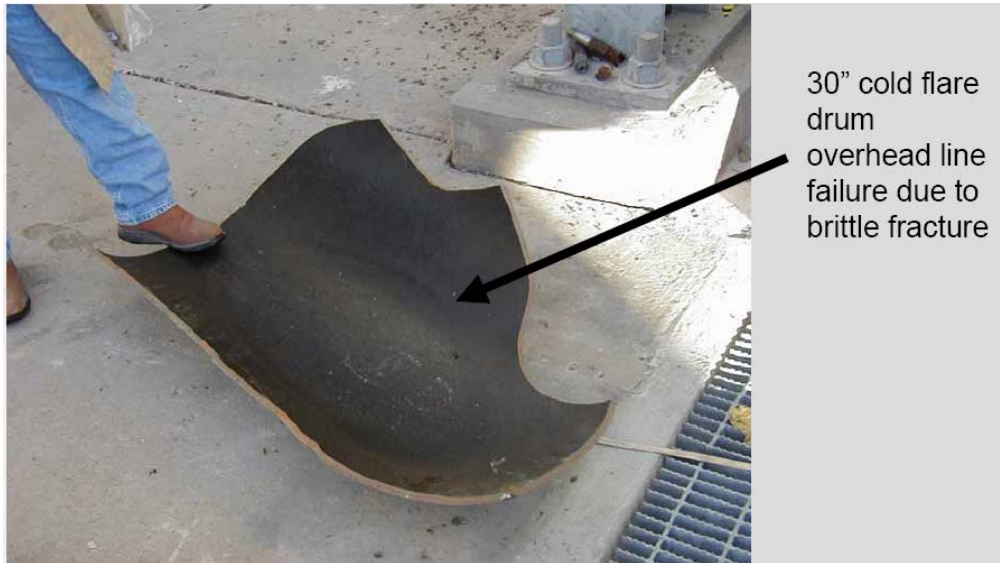
The final stress that ultimately caused the brittle fracture of the piping has not been identified, but could have been any number of internal or external stresses. 1) External stress - Hard rain that came at the time of event, 2) Internal stress - Contraction of the cold flare line due to temperature gradient.

The incident causes an explosion and damage to equipment, but no first aid or recordable incidents to personnel. As a result of the incident the ethylene plant upgraded many carbon steel systems to stainless steel, which has a lower temperature limit.
