*Ethylene Unit Pyrolysis Furnace  
Opportunity  
& Strategic Improvements*

# *Pyrolysis Furnace Opportunity & Strategic Improvements*

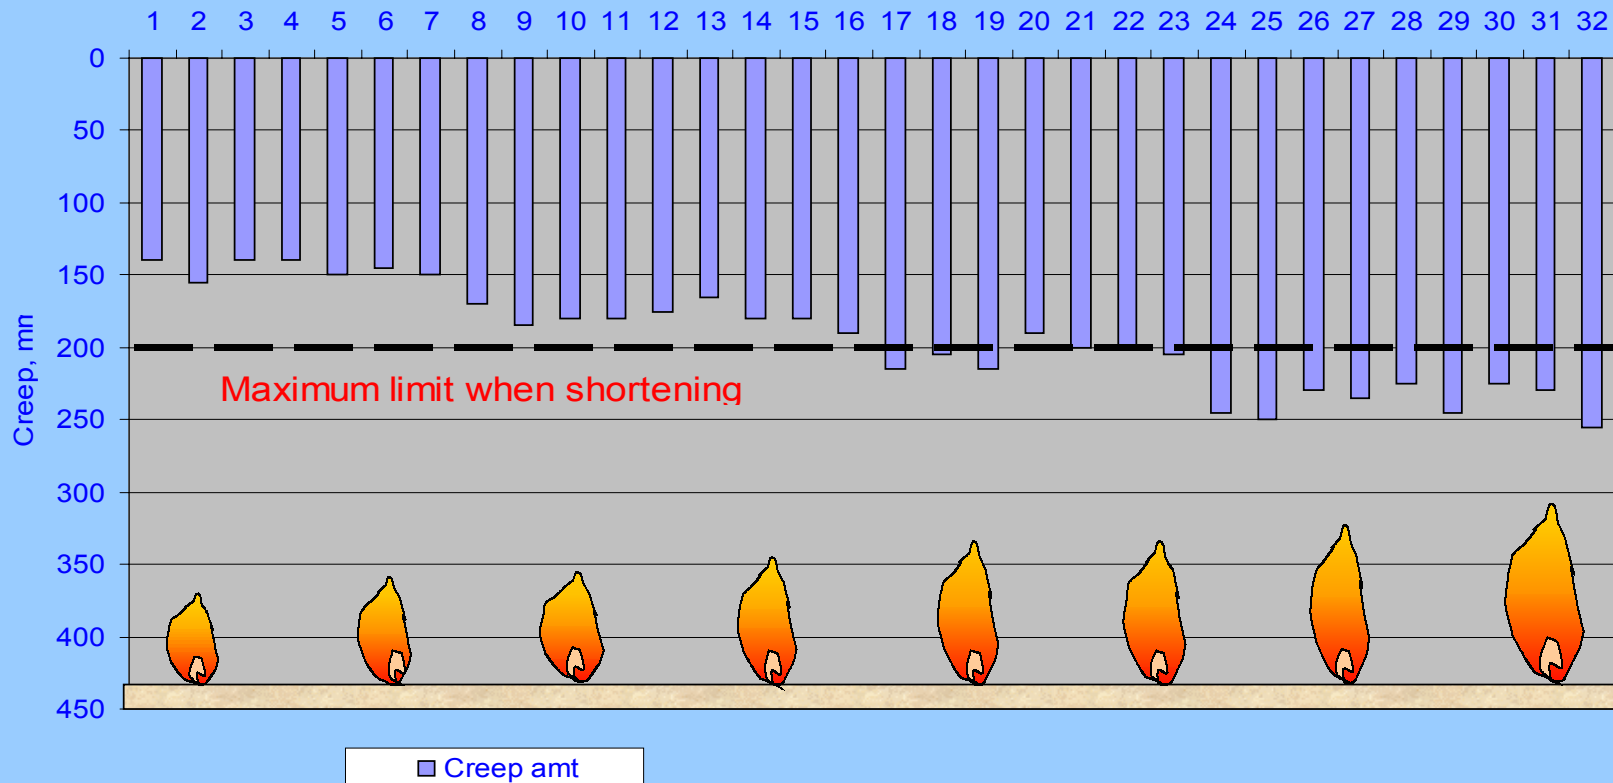
- Creep rate is between 60 - 78 mm per year in one zone example
- Coil needs shortening approx. every 5 years
- Recycle zones are fired harder to achieve optimum yield causing higher Tube Metal Temperature (TMT)

- Flame impingement
  - burner tip blockage
- Heat maldistribution
  - uneven firing
  - mixture of old & new burner tips
- ASWT
  - average sound wall thickness
  - thicker walls more prone to creep

- Burner tip cleaning and maintenance
- Coil elongation monitoring
- Future:-

Kubota MERT tubes -  
lowers TMT's by  
increasing heat transfer

Auto Excess O2 control -  
lowers firing needs

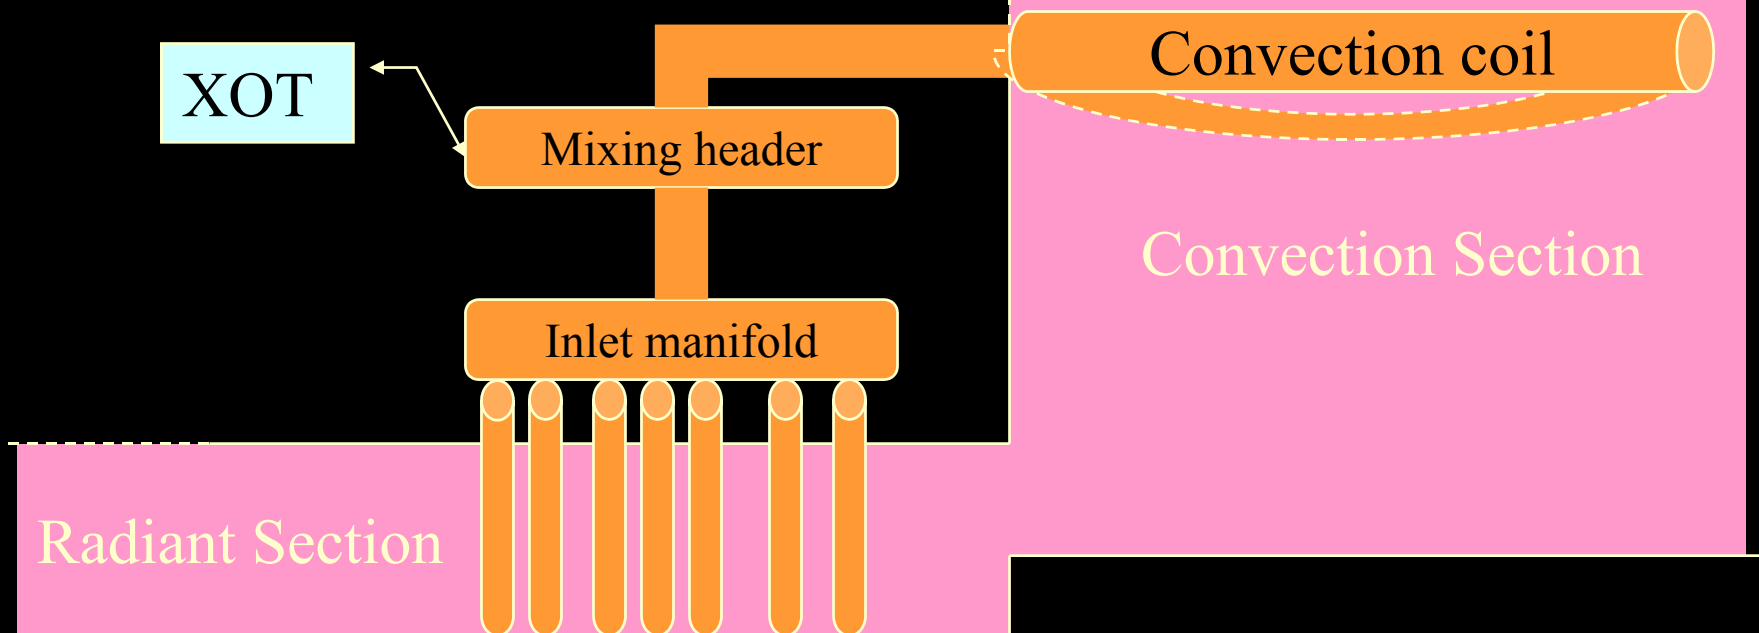
- Bottom section of convection bank bowed approx. 30cm
- Cracks at weldment from mixing header to inlet manifold

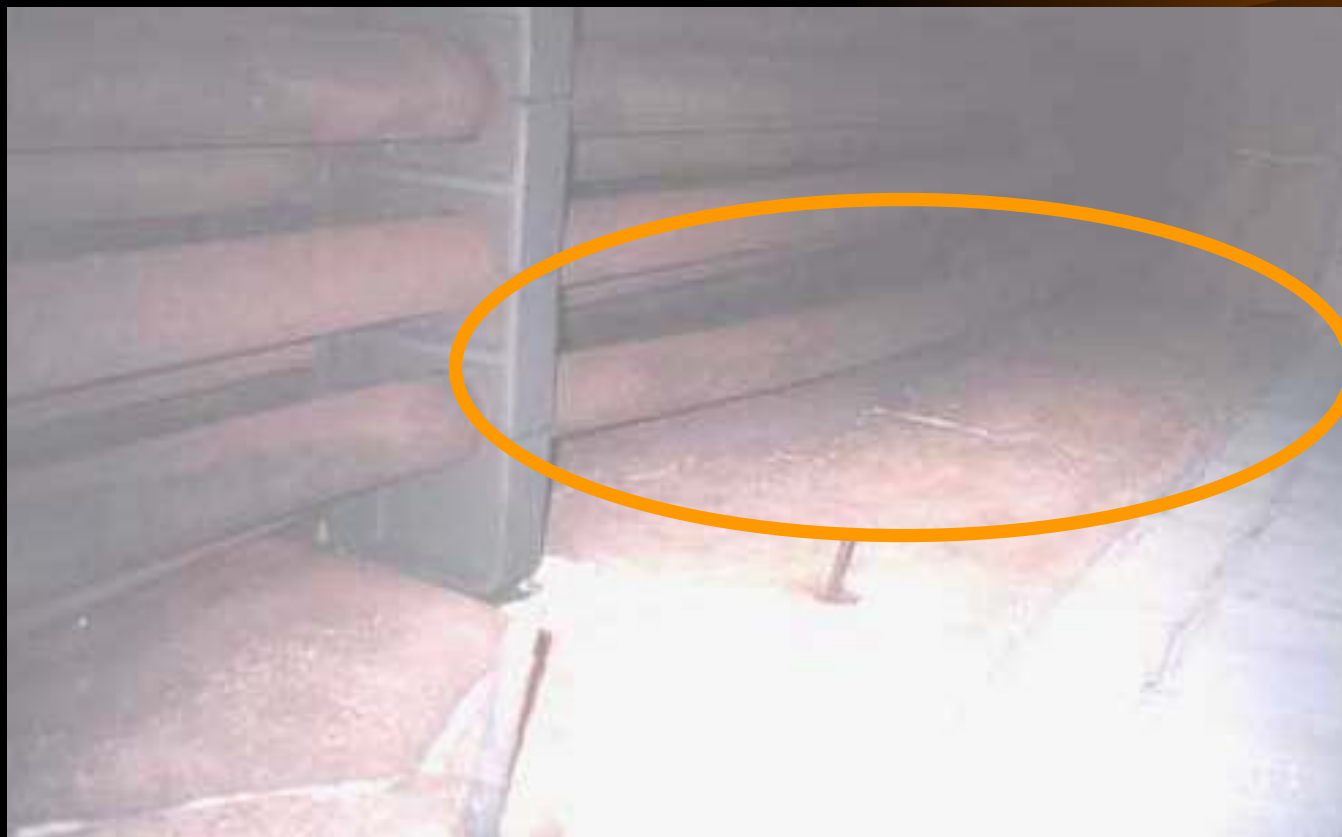
- Zone mainly recycle feed
- Recycle cracking requires higher Coil Outlet Temperature for conversion
- Excess heat recovered in convection

- Too much excess heat raises XOT temperature which initiates premature cracking
- Metallurgy limits promotes creep and expansion

- Stress analysis required on piping and full understanding of metallurgy limits
- Spring hanger adjusted to relief piping stress
- Bowed convection coils replaced
- Secondary steam injection optimized

- Upgrading of crossover and convection material
- protect convection coils by insulative material

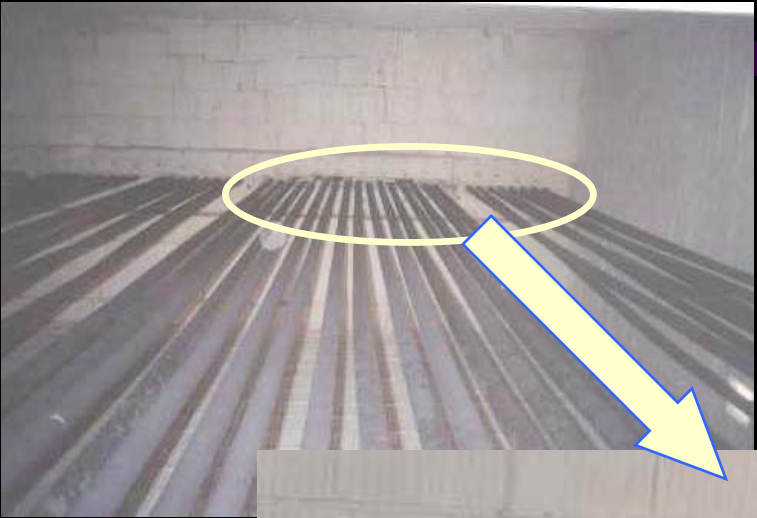
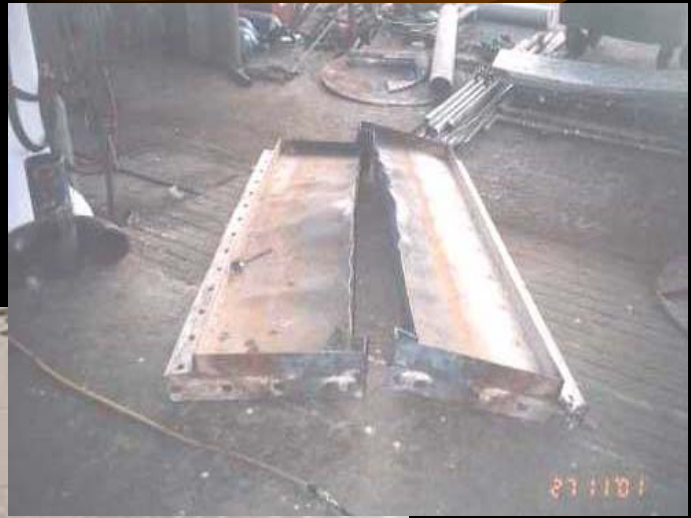
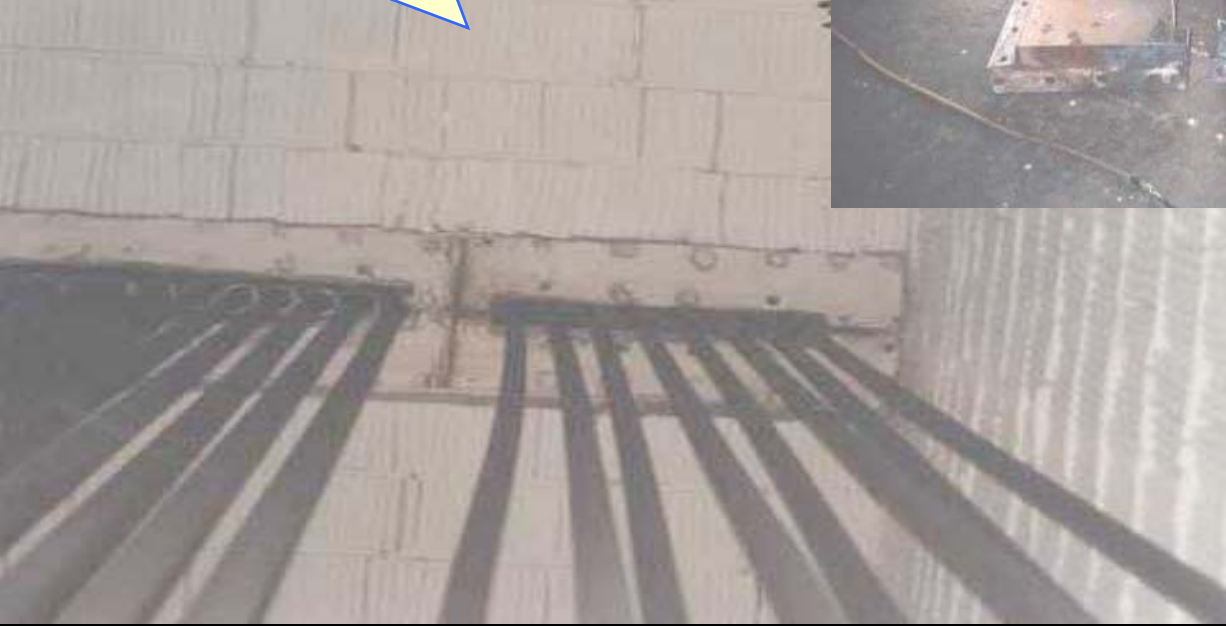
- Insulation around radiant outlet replaced and shadow box plates upgraded to SS304 after turnaround
- Hotspots detected on shadow box during thermograph survey

- Plates deteriorated and warped
  - Some insulation cladding melted
  - Insulation material noticed on firebox floor

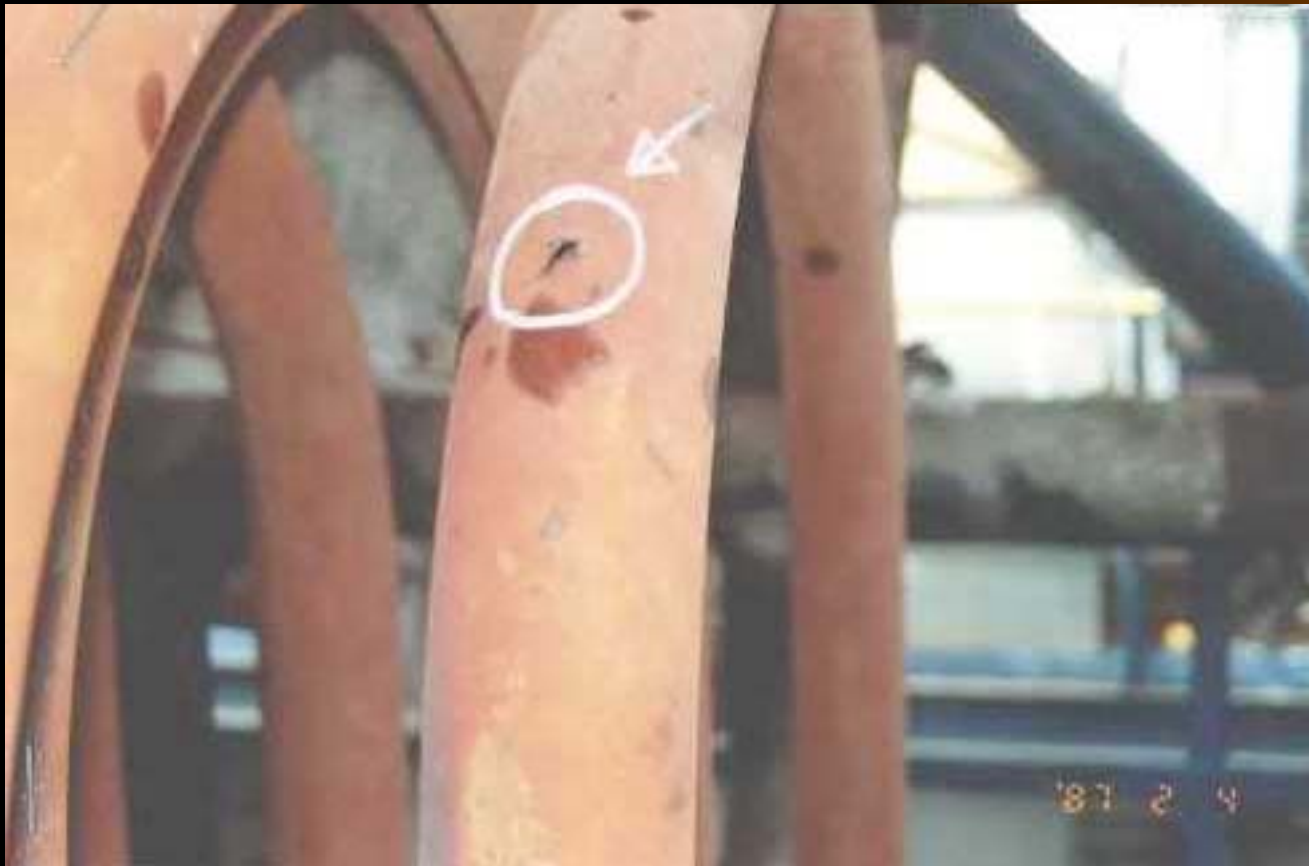
- Thinning 1mm per year at the inlet sweep bend
- Change U-bend if thickness drops below 3.5 mm from initial of 8.8mm
- Replacement every 3 years

- Erosion main contributing factors include solid presence, material specification and flow path geometry
- Initially, gradual transition in flow section and shallow-angle intersections was enough to mitigate erosion

- Inlet and outlet sweeps alternated to even out erosion effect
- Ultrasonic Thickness Scanning (UTS) to detect thinning and make replacements
- Modify U-bend to increase integrity of pipe inline with increasing flow turbulence

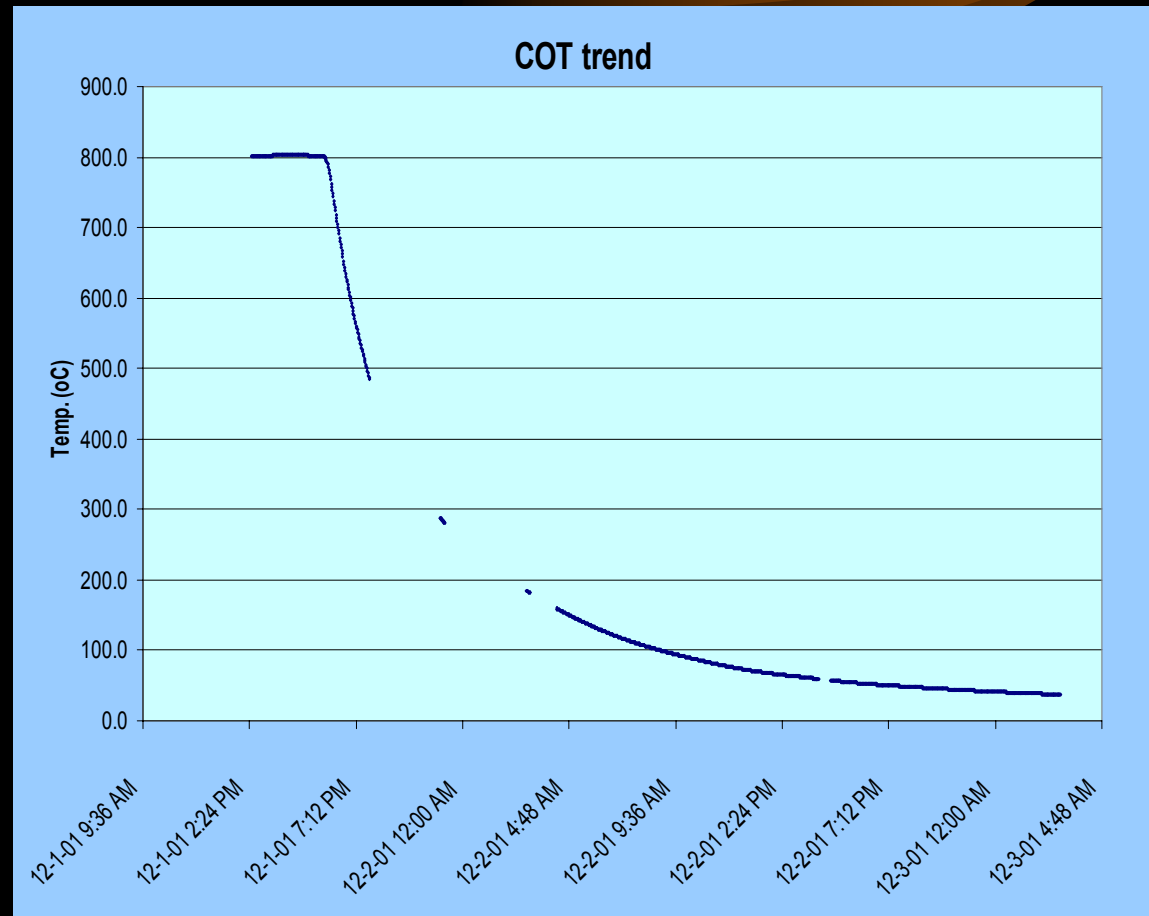
- Coil temperature drops 100 ~200 °C in 1st hour after trip
- Allowable temp. drop is <80 °C

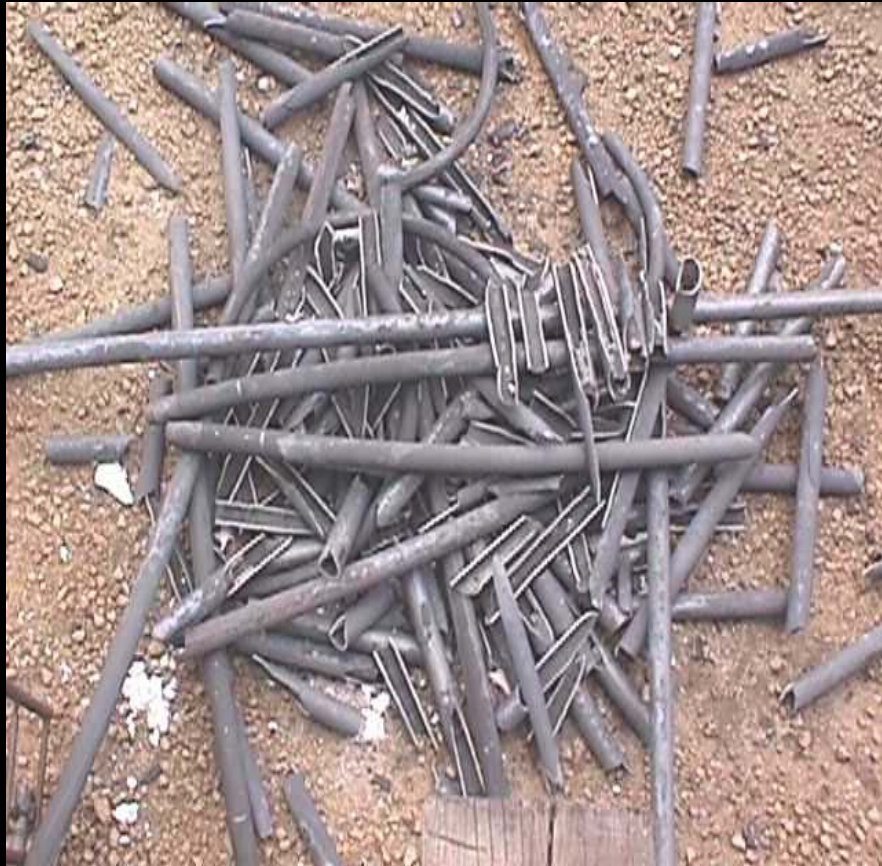
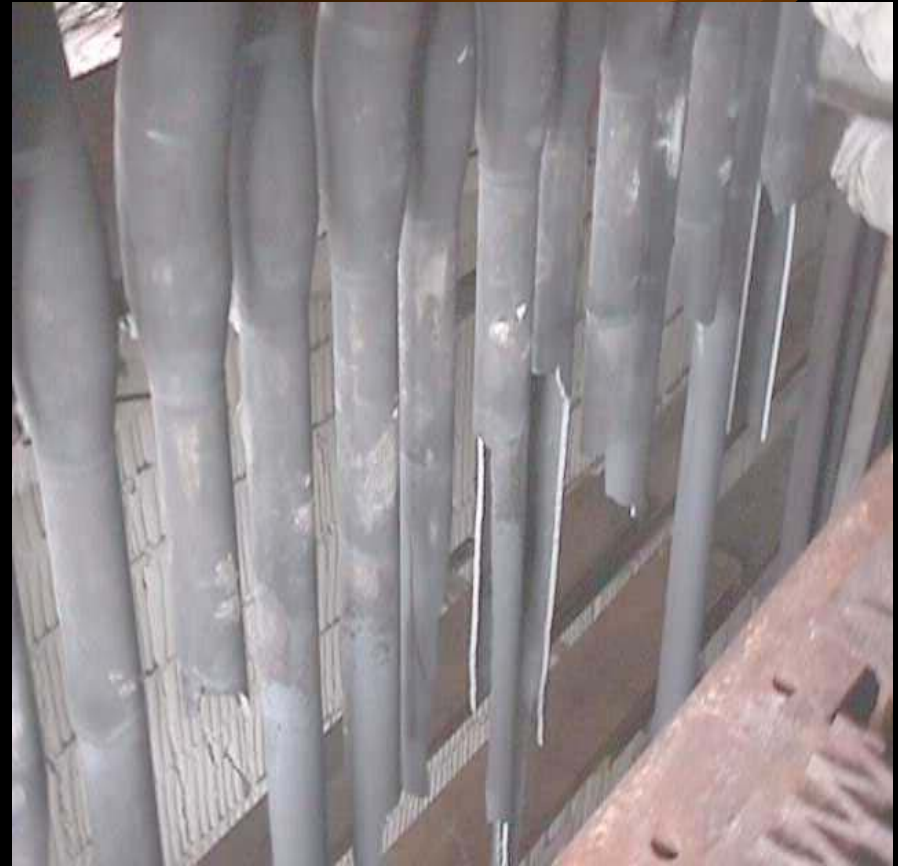
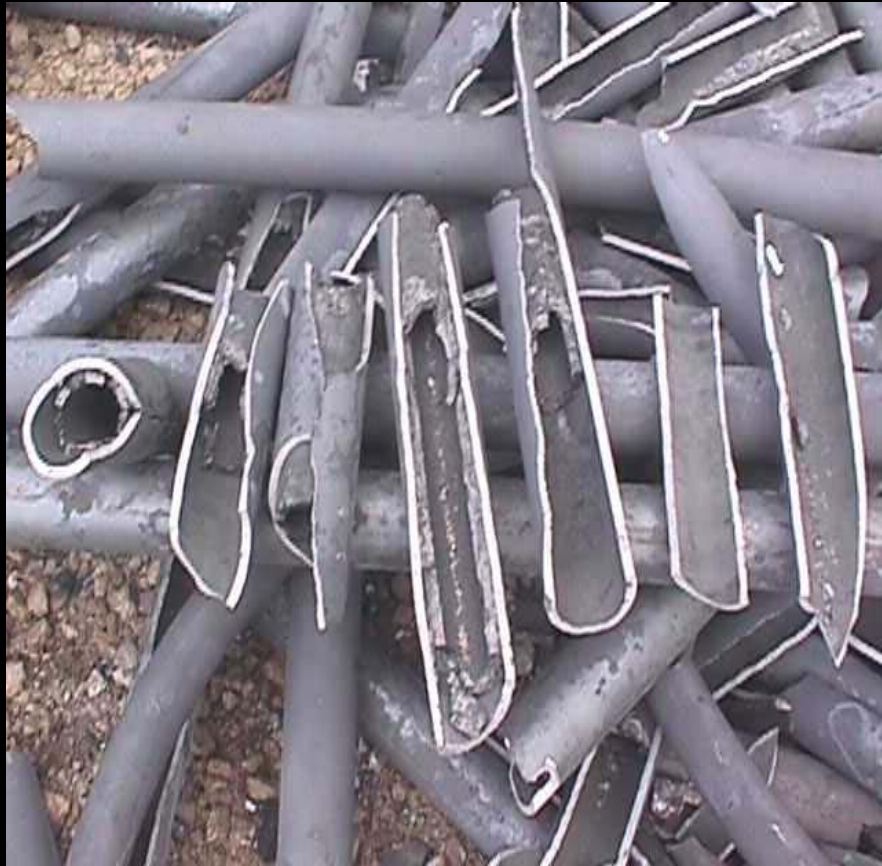
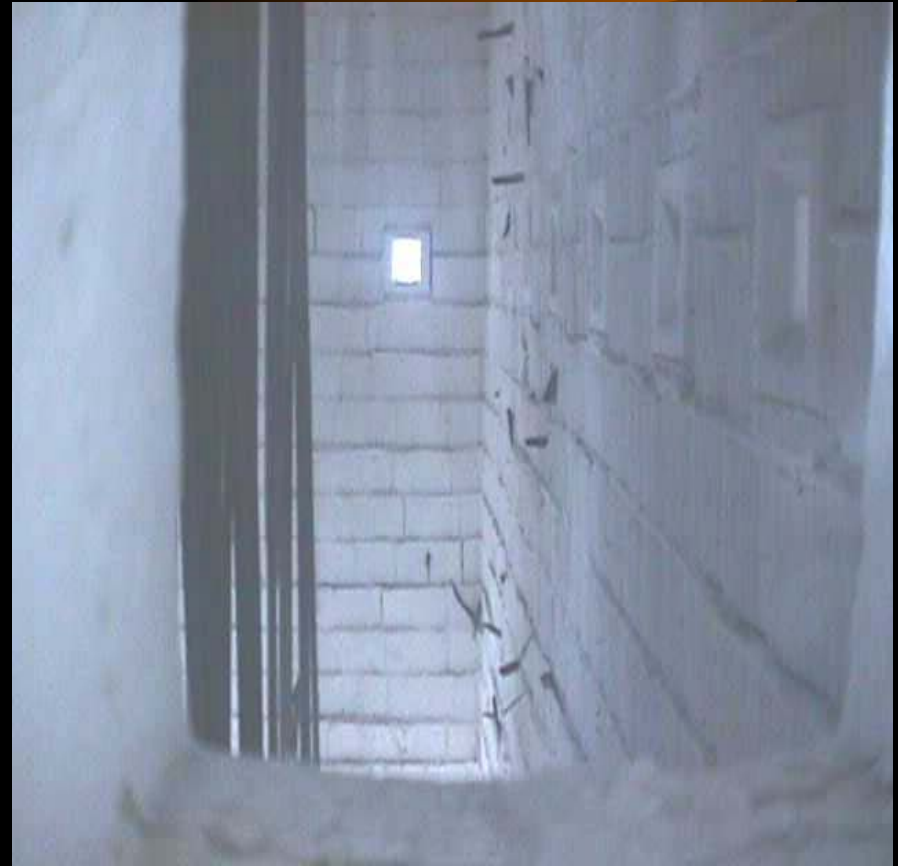
- Coke layer is hard, relatively brittle, and has a lower coefficient of thermal expansion than the tube metal
- With coke presence during sudden shutdown two things can happen:-
  - ~ coke falls off - spalling that leads to tube blockage
  - ~ coke remains - coil splitting due to it's faster rate of contraction

- Difference in cooling rate depends on amount of coke and insulation condition
- Coils inspected after temperature almost ambient : ~ 70 coils needed replacement

- Decoke End Of Run tubes as soon as possible before shutting down furnaces
- Avoid unnecessarily furnace emergency shutdowns
- Ensure reliability of Uninterrupted Power Supply (UPS)
