Improve the Reliability of High Flux Reboilers

A Treatment Approach for Dilution Steam Generator (DSG) Reboilers in Ethylene Plants

Karl Kolmetz¹

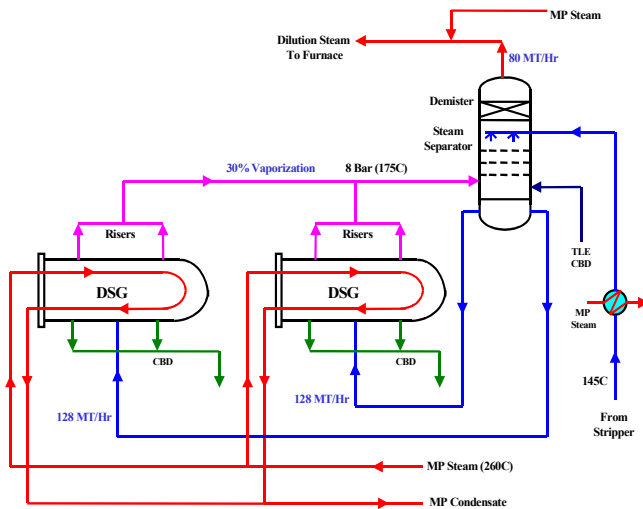
Figure 2: The Ethylene Unit Example's DSG Reboiler % Evaporation and Circulation Flow Rates.

In standard industrial boiler design, the % evaporation rate over water circulation rate is typically about 10% to ensure proper water circulation. Figure 2 shows the schematic of the Ethylene unit example's DSG system, water circulation and steam generation rates.

From the above review, it can be concluded that the previous amine treatment program apparently unable to provide satisfactory corrosion protection in DSG reboiler designed with high % evaporation rate. When operating under high % evaporation rate, the even water circulation in the entire horizontal reboiler can be compromised. As a result, pockets of steam/water separation will develop in the upper section of the reboiler. The existence of water line at certain areas in the upper section of the reboiler during inspection at the Ethylene unit example is a testimony to steam/water pockets formation. In addition, high evaporation rate in combination with steam/water separation promote iron and hydrocarbon deposition. This creates potential for localized under-deposit organic acids concentration, which leads to low pH corrosion effect.

At the Ethylene unit example, currently two reboilers are in service with one on standby. With all three reboilers in service the % evaporation would be lower (theoretically 20% lower), and consequently will help to reduce the propensity to develop high heat fluxes on the reboilers' tubes.

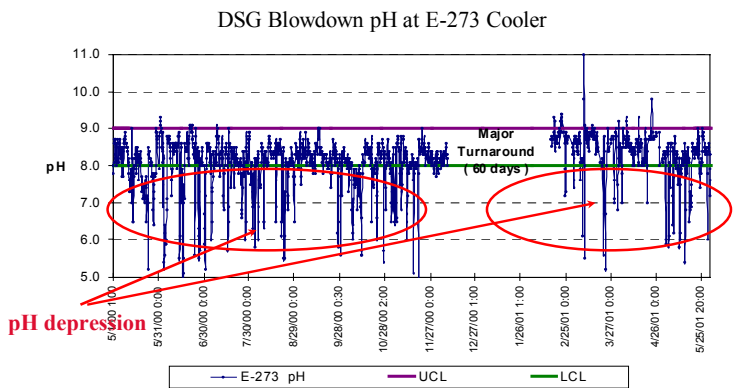
Chart 1: pH Trend at DSG Blowdown Before New Treatment Program at the Ethylene Unit Example.

Chart 1 shows the pH control trend for DSG reboilers blowdown at E-273 cooler before the new treatment program was implemented. The target pH control range was 8.0–9.0. The DSG blowdown reactive iron trend is shown in Chart 2. The average blowdown iron was 1.6 ppm.

About 10–40% of the time (6 pH data points per day), the reboiler water pH controls were less than 8.0. At pH below 8.0, the passive magnetite film, which protected the carbon steel, would be destroyed; and as such, significantly increased the general corrosion rate.

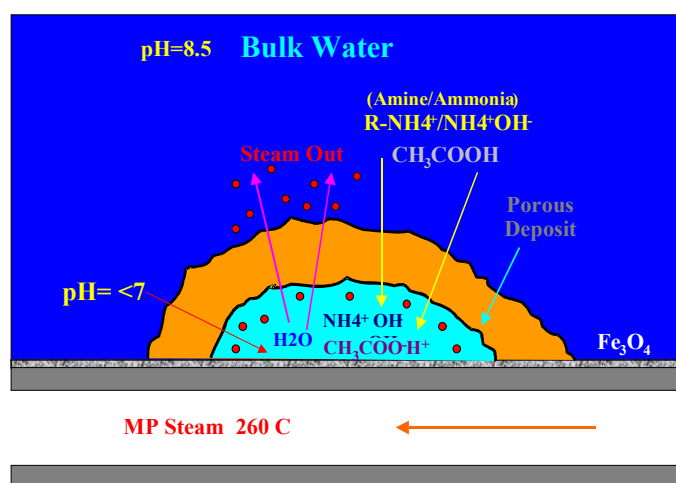
Figure 3: Under-deposit Concentration Cell–Low pH Corrosion.

section of the reboiler where bulk of the evaporation was expected to take place. The under-deposit corrosion developed as a result of the concentrated organic acids (mostly acetic) underneath the porous deposit as illustrate in Figure 3.

The contaminants in DSG water include organic acids (majority acetic, some propionic & butyric), ammonia and some carbonates. Typical acetic acid level in blowdown is 300 – 600 ppm. Ammonia in the DSG incoming water is about 20 – 50 ppm. The corrosion protection rendered by the previous chemical treatment program used a low volatility neutralizing amine to neutralize all the acid species and elevate the water pH to 8.0 – 9.0. Ammonia, an alkaline compound has the same effect as the amine. It is however, much more volatile.

When bulk water at alkaline pH enters the porous deposit, compounded with the high % of evaporation rate taking places at the upper section of the bundle, the condition for setting up concentrated cells under the deposits (like a miniature boiler) prevails. The highly volatile ammonia will vaporize and travel with the steam, upsetting the base/acid ratio in the water phase. This can result in a localized low pH environment, which is highly corrosive towards magnetite and carbon steel; thus ultimately leads to tube leak.

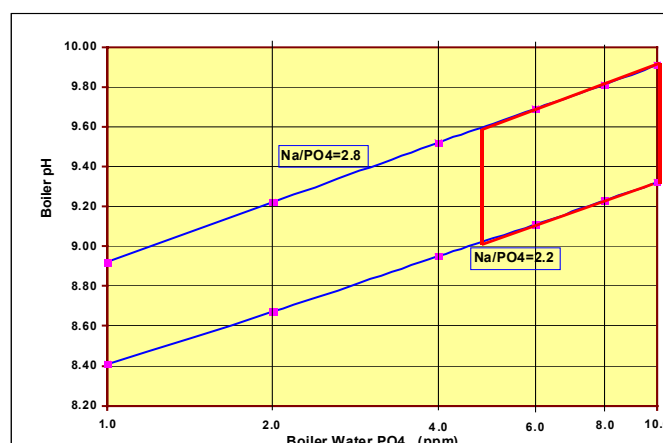
Chart 3: Phosphate /pH Coordinate – Chemical Treatment for DSG Reboilers.

The Na and Ortho-PO₄ chemistries are controlled based on coordinated pH/ PO₄ coordinated as shown in Chart 3. The recommended control limits are 5–10 ppm Ortho-PO₄ and pH at 9.0-9.8. This involves two-dimensional control to keep the data points in the control box. Conformance to the coordinated pH/ PO₄ control range (Na/PO₄ molar ration between 2.2 –2.8) ensures no free caustic the DSG blowdown.

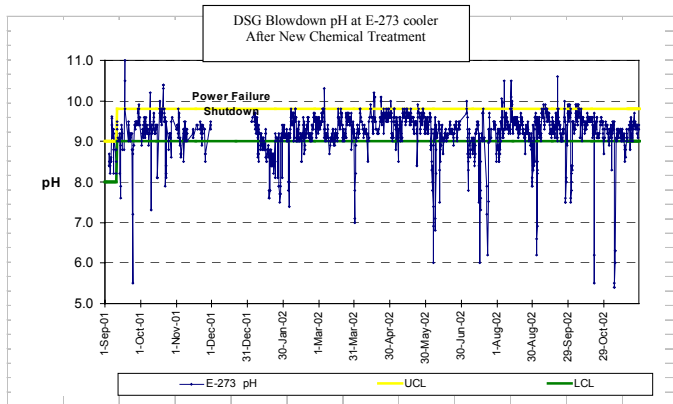
Chart 4: pH Trend at DSG Blowdown after the New Treatment Program at the Ethylene Unit Example.

As shown in Chart 4, the pH control is more stable in the range of 9.0 – 9.8. The pH depression below the target limit has been reduced.

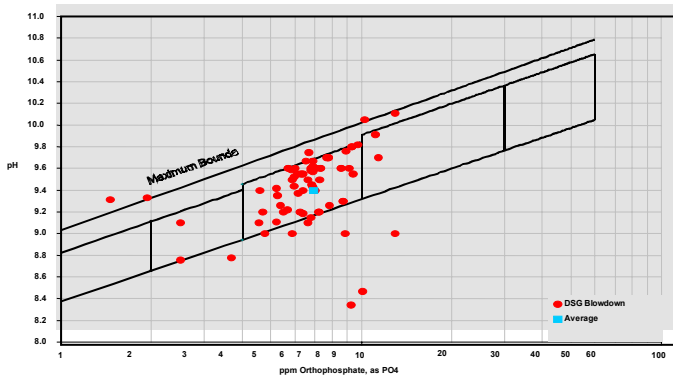
Chart 5: Coordinated pH/PO₄ Control in DSG Blowdown After New Treatment Program at the Ethylene Unit Example

Since the new DSG program is using the coordinated pH/PO₄ approach, the control of pH within 9.0 – 9.8 and PO₄ within 5 – 10 ppm is very essential. Chart 5 shows the Coordinated pH/PO₄ control for the new DSG chemical treatment program.

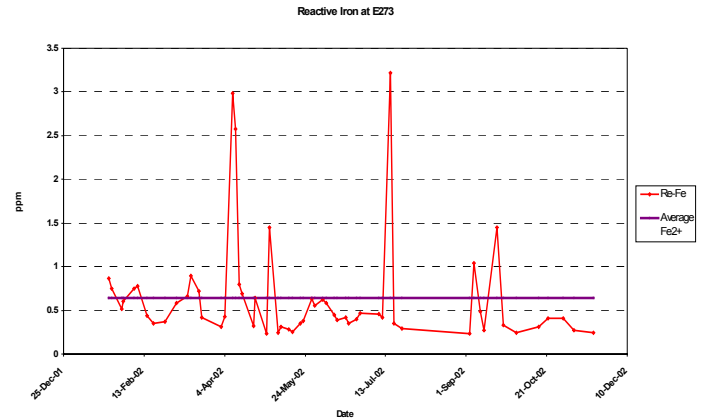
Chart 6: Iron loading of pH/PO₄ coordinated program.

The most important key performance indicator of the new program is the reduce corrosion and iron fouling rates by monitoring iron loading at the blowdown cooler, E-273, and the tubes failures history. As shown in Chart 6, the iron loading in DSG dropped from 1.6 ppm to below 0.6 ppm. This is more than 60% of iron reduction.
