Troubleshooting Practice in the Refinery

Andrew W. Sloley
The Distillation Group, Inc.
PO Box 10105
College Station, TX 77842-0105

Prepared for presentation at the
AIChE Spring National Meeting

23-27 April 2001

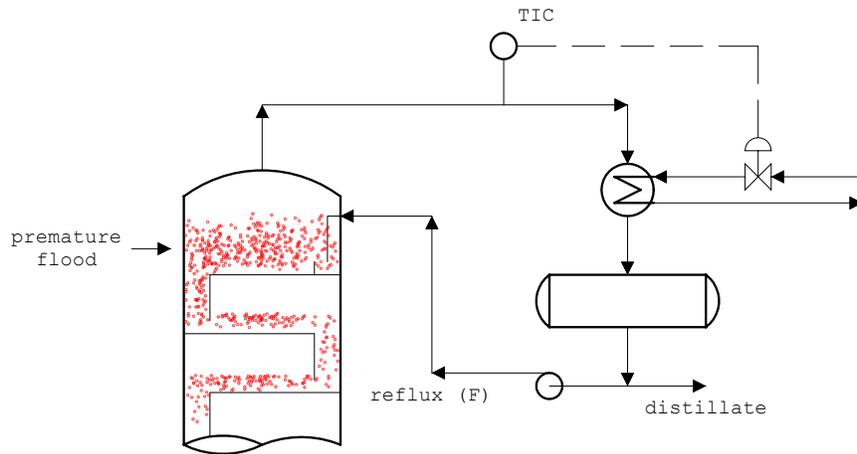
Figure 2
Subcooled reflux and premature flood

When a sub-cooled liquid feed is used, the increase in liquid molar flow at the feed stage is greater than the liquid molar feed rate alone. Vapor rising to the feed stage is condensed in order to raise the feed conditions to the bubble point temperature. The condensing vapor increases the liquid flow leaving the feed stage, flooding the column (Figure 2).

The results of the simulation indicated that the liquid traffic in the rectification section of the column was dramatically higher than previously used in the design. The internals were re-rated with the loadings from the simulation. It was determined that the column would get about five percent less capacity than planned. This was consistent with the results seen from the simulation and the gamma scan.

Sub-cooling the reflux was a normal part of the operation of the plant. The reflux was subcooled to make the plant more energy efficient. This practice could be abandoned if necessary. The operations group agreed to increase the temperature of the reflux in order to determine if this was the problem with the column. Once the reflux was introduced to the column at bubble point temperature, the capacity and efficiency of the column increased. The column was able to handle the new design-operating rate and the efficiency of the column was within design specifications.

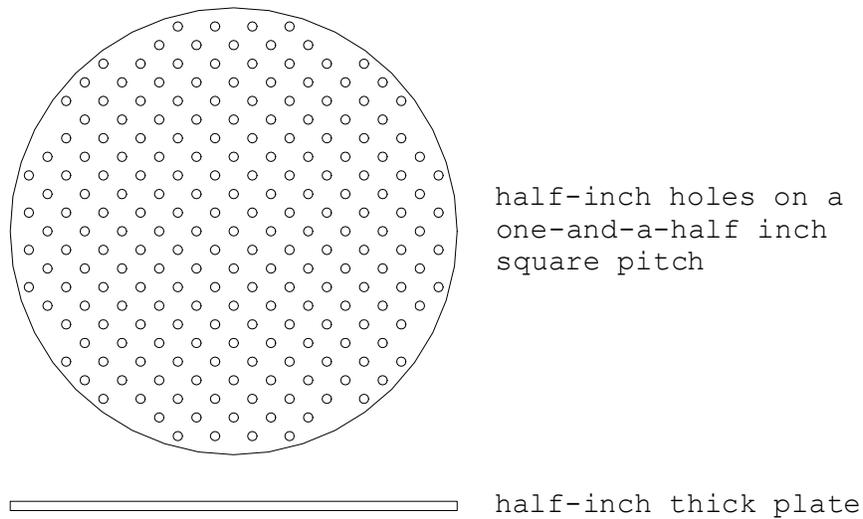
Figure 3 shows a perspective view of a liquid distributor that the author found installed in the column. Six years earlier, the plant had converted the stripper from a trayed column to a packed column. During the conversion, three homemade "supports" as shown in Figure 3 were installed to support the packing beds. Figure 4 shows the support locations in the side stripper. No after-modification test was run to check the performance of the modified unit.

The homemade support installed has a major defect. It had insufficient open area for vapor flow (9.2%). In a packing support plate, vapor flowing up and liquid flowing down have to share the same openings. For the liquid to flow down, the liquid height above the support plate has to overcome the pressure drop of the rising vapor. A small open area gives a high-pressure drop. The result was a cyclic operation where liquid stacked up above the distributor plate until enough liquid head was available to force the liquid down against the force of the rising vapor. Once liquid flowed, it dropped down the tower in a slug. This drained the liquid level above the support plate and started the entire cycle again. The liquid slugging showed up as a product viscosity variation.

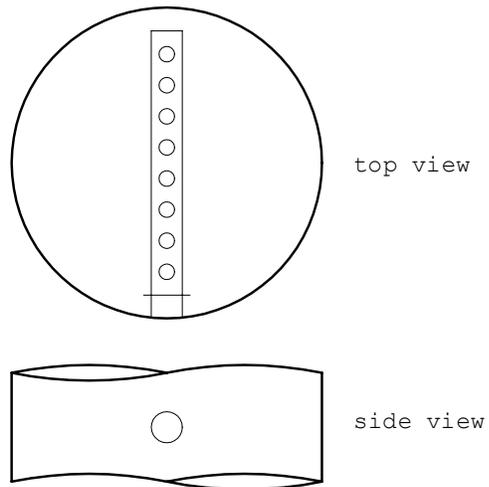
Figure 7
Unshrouded vapor side draw

However, a problem arose when the unit was commissioned. The aromatic vapor sidecut now contained a much higher amount of solvent. Independent review at this point discovered the causes of the problem. The valves did not have a positive liquid seal and they weeped slightly, letting some solvent drop into the vapor draw header (Figure 7).

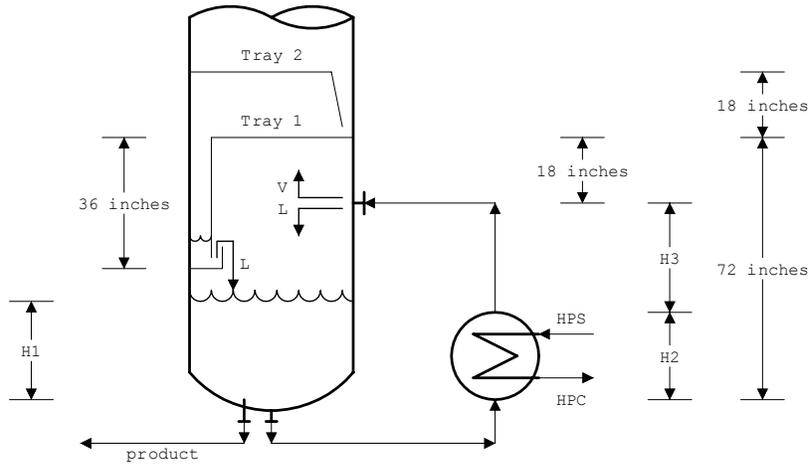
Figure 10
Recirculating thermosiphon arrangement, after revamp

After the revamp, the column was started up and lined out. The column did not work. The problem was determined to be insufficient boil-up. This was found through analysis of field data and comparison of simulation work done before the column was revamped. After reviewing the revamp design of the column and inspection records, it was determined that the internal pipe feeding the reboiler and the tray sump had been removed. The liquid level driving flow through the reboiler was substantially reduced, thereby creating flow instability problems in the reboiler loop (Figure 10).

In order to increase the amount of liquid flow the liquid driving head must increase. The hydrostatic pressure difference between H1 and H3 has to be decreased (Figure 10). As the liquid driving head increases, the circulation rate increases, lengthening the nucleate boiling zone and reducing the mist flow zone. As this occurs the performance of the reboiler improves.

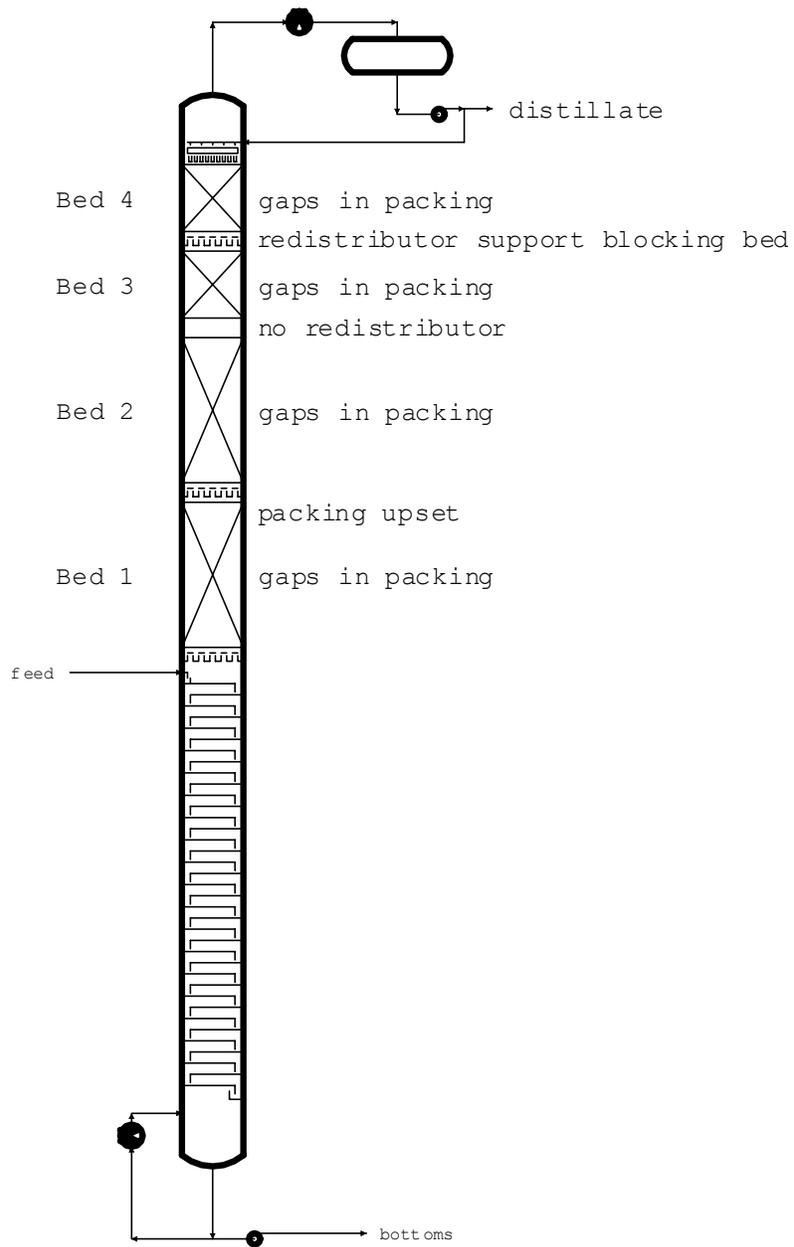
Figure 12
 Inspection results on extractive distillation tower

During the shutdown, maintenance personnel inspected ED (Figure 12) and stripper towers. In the ED tower packing was found to be up to 1/2 inch (12.7 mm) from the circumference of the wall. The packing also contained up to 1/2 inch (12.7 mm) openings in the middle of the bed. This can lead to channeling down the wall or through the openings in the middle of the bed with a loss in packing efficiency.

Engineers need to insure that packing sections are fully packed, contain hold-down grids, and have a collector and redistributor. Problems are easier to prevent than to fix.

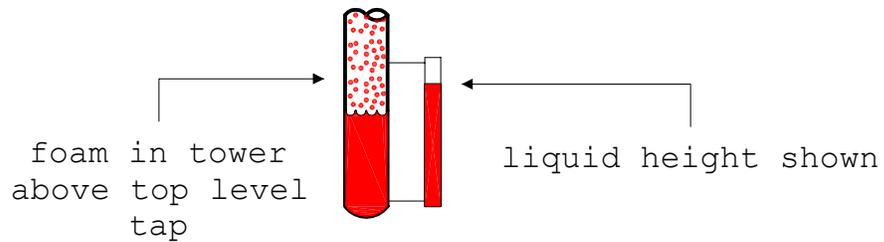
Figure 16
Foam and complete filled tower

Once foam rises above the upper level tap for the DP cell (Figure 16), then the DP cell (or sight-glass) only shows average density inside the column, not liquid level.

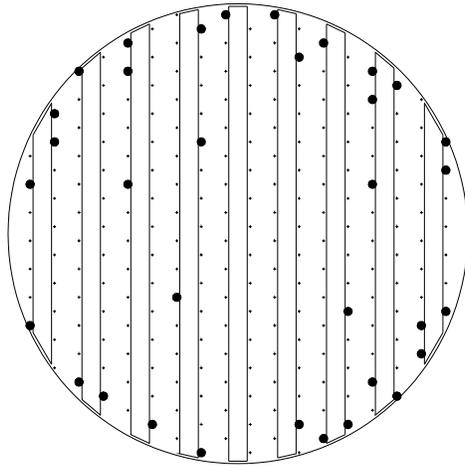
Figure 19
Fouling found on trough distributor

The tower was shut down for repair and the existing distributors were inspected. Several problems were found with the existing distributors. Many of the trough orifices were plugged. The orifices plugged were mostly at the outer area of the distributor. This type of plugging was ob-

The plugging problem was the cause of the worsening performance over the run. The out-of-level installation was the cause of the tower never meeting its full potential. Many towers fail to meet their operating targets for these reasons. Features can be added to the distributor to reduce the effects of fouling inside a tower [10]. Standard designs often do not include these features. Inappropriate application of standard equipment and practices is a major source of operating problems and lost profits.

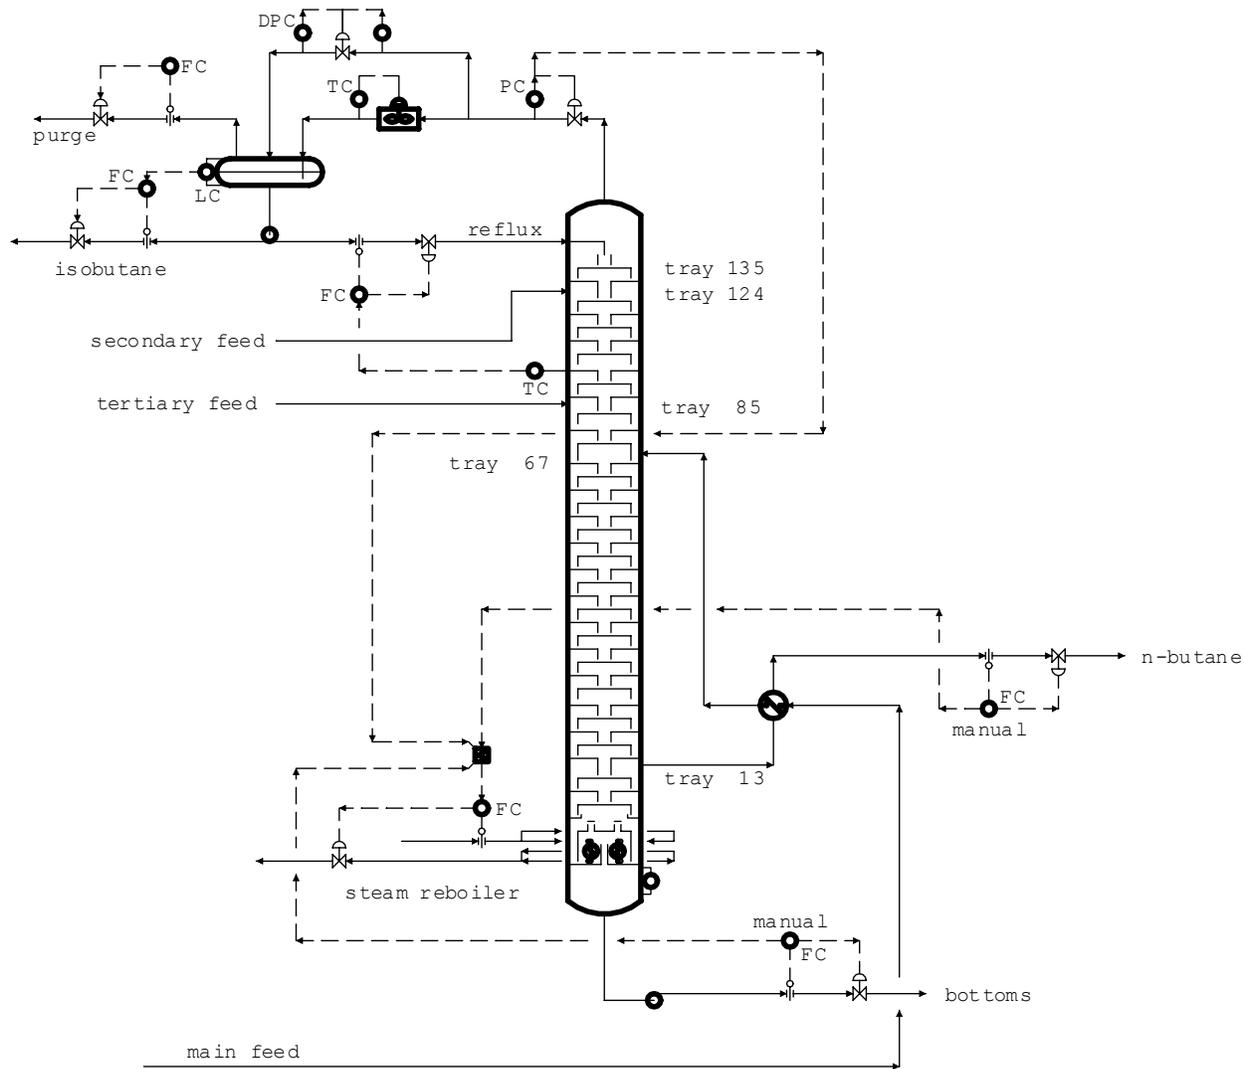
Figure 23
Control scheme derived by operator experimentation

After considerable experimentation, the major contributing factor for control failure was found to be the bottoms level. Taking the bottoms level loops out of the control system stabilized unit operation dramatically. The actual control scheme derived from operator experimentation had the bottoms and sidedraw products on flow control. Flow rates were reset manually as the affects on downstream operation were seen. Typically, the bottoms rate was kept much higher than necessary to allow for stable operation of the rest of the plant. Figure 23 shows the configuration used.

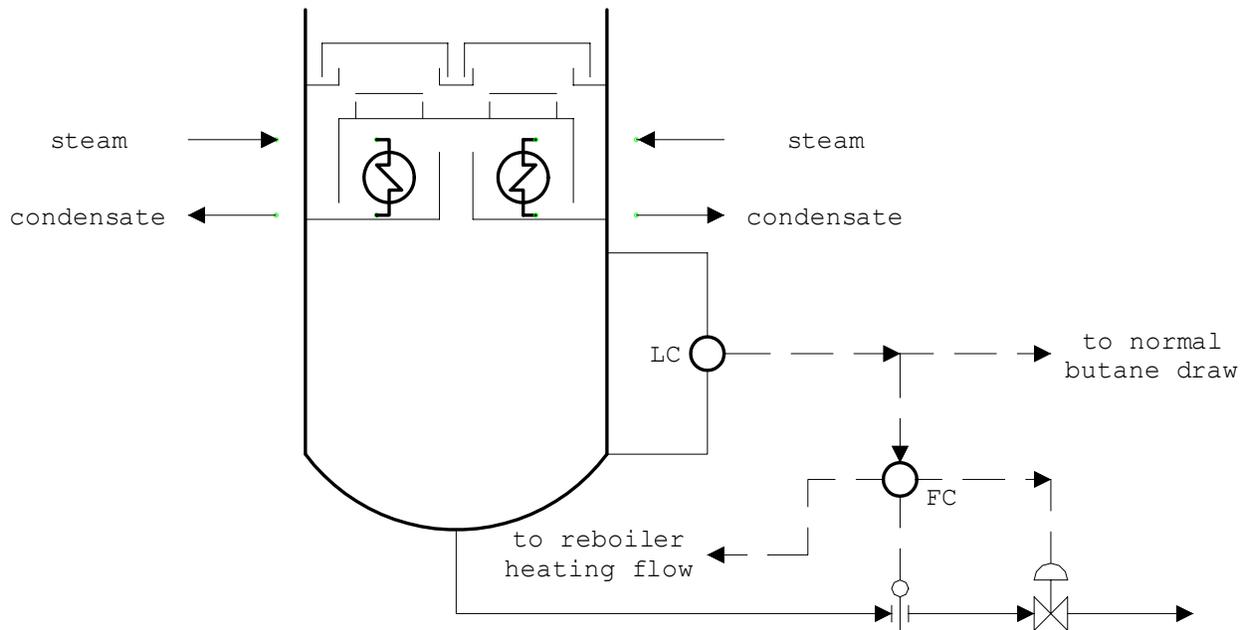
Figure 25
Deisobutanizer boot with stab-in reboiler expected (correct) configuration

Before the shutdown, a more thorough review of the problem source was conducted. Figure 25 shows the expected configuration of the tower bottoms based on using a chimney tray to hold liquid on the stab-in reboilers used. Figure 26 shows the configuration as installed and shown on the tower and internal equipment drawings. Inspection photographs found in the files verified this configuration.

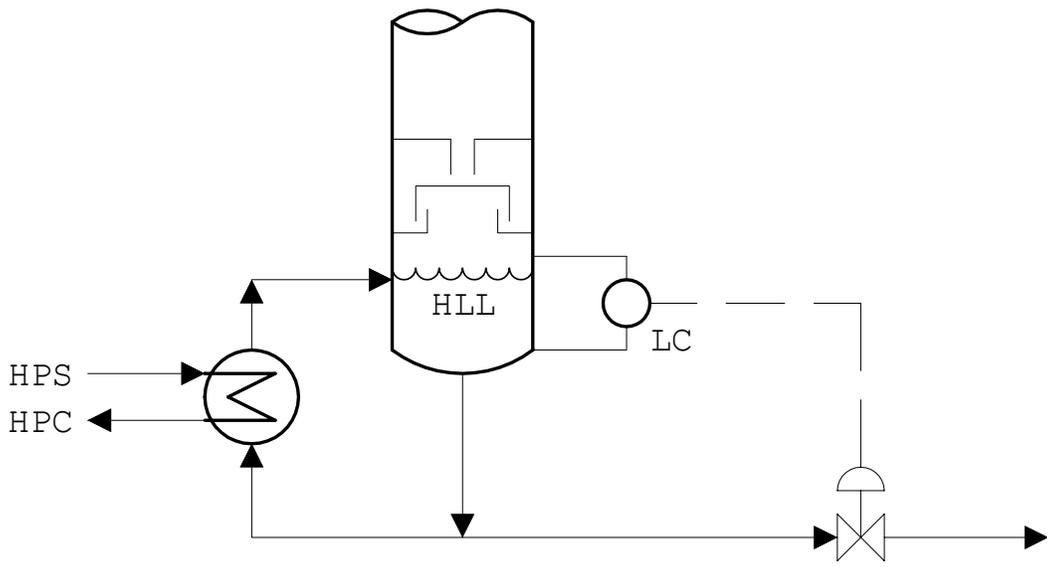
Figure 28
Liquid level at reboiler return

After analyzing the data collected from the test and the gamma scan it was found that there was a level controller in the bottom of the column that was out of calibration. The liquid level was even with the reboiler return nozzle. The high level resulted in liquid being entrained to the bottom tray, Figure 28. If the liquid level in the bottom of the column rises above the reboiler return nozzle vapor from the reboiler can entrain liquid into the first tray in the bottom of the column. The condition can lead to many column operational problems.

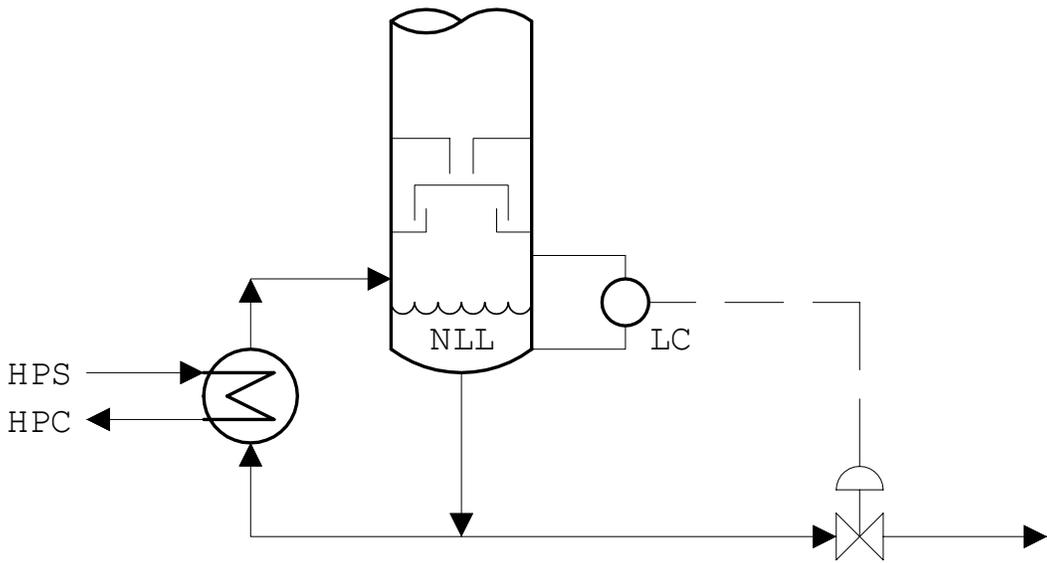
Figure 29
Liquid level normal

Once this problem was corrected the column operation improved. The column pressure drop went from 12 psi (83 kpa) to 10.5 psi (72 kpa). The product purity in the overhead rose above 99.6%. The impurity in the overhead did not change significantly. The decrease in pressure drop is an indication that premature flooding was taking place, Figure 29.

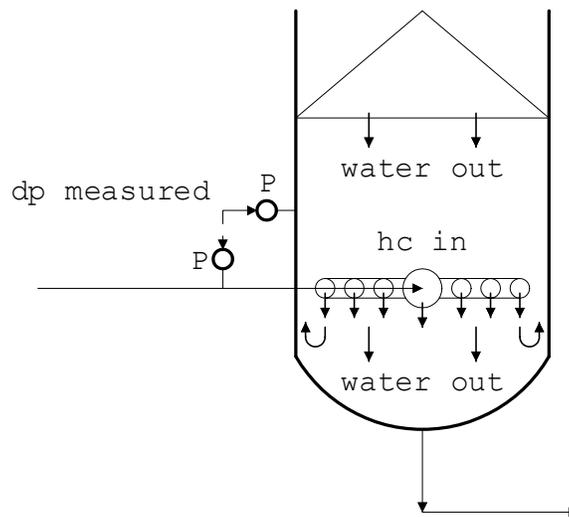
Figure 32
DP measurement

Various theories were proposed to explain the source of the problem. As part of the troubleshooting effort, a pressure gauge was placed on the hydrocarbon feed line to the unit (Figure 32). The pressure differential found between the feed line and the vessel showed a pressure drop across the distributor approximately five times the expected value. Further investigation showed that the hydrocarbon distributor had partially fouled during the first run of the plant.
