Ethylene Unit Pyrolysis Furnace Opportunity & Strategic Improvements

Pyrolysis Furnace Opportunity & Strategic Improvements

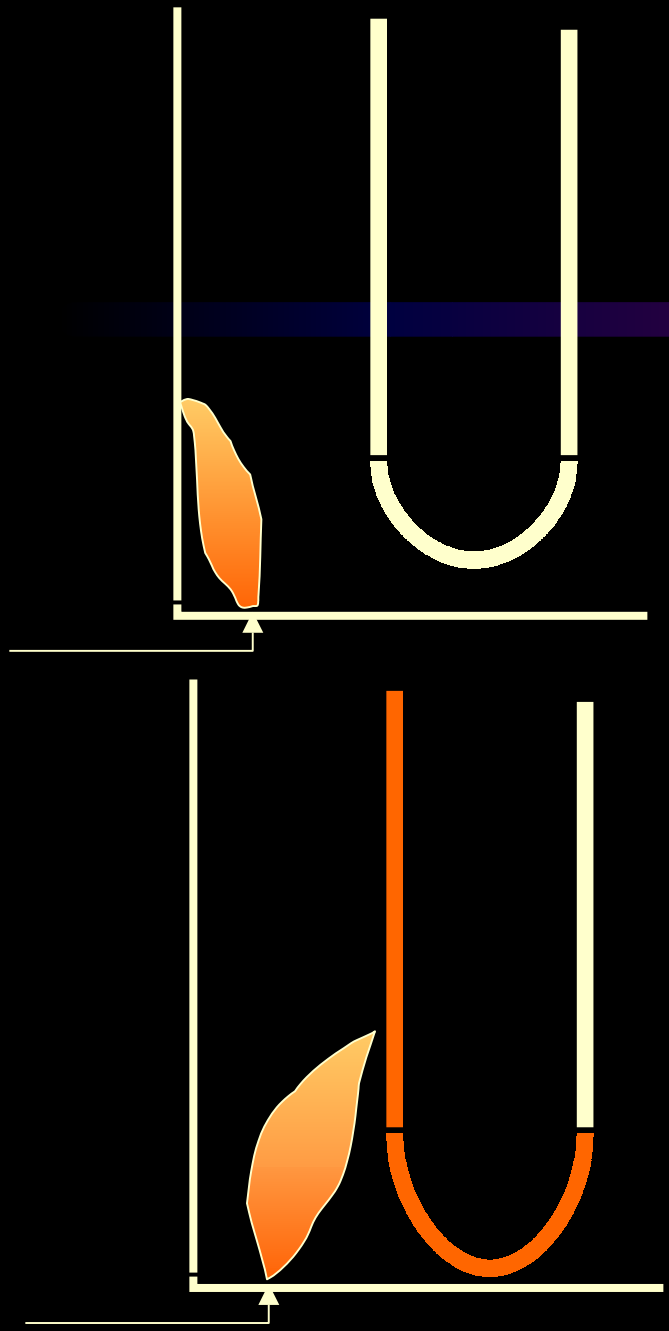
1st Opportunity : Coil Elongation - scenario

- Creep rate is between 60 - 78 mm per year in one zone example
- Coil needs shortening approx. every 5 years
- Recycle zones are fired harder to achieve optimum yield causing higher Tube Metal Temperature (TMT)

- Flame impingement
  - burner tip blockage
- Heat maldistribution
  - uneven firing
  - mixture of old & new burner tips
- ASWT
  - average sound wall thickness
  - thicker walls more prone to creep

- Burner tip cleaning and maintenance
- Coil elongation monitoring
- Future:-

Kubota MERT tubes - lowers TMT's by increasing heat transfer

Auto Excess O2 control - lowers firing needs

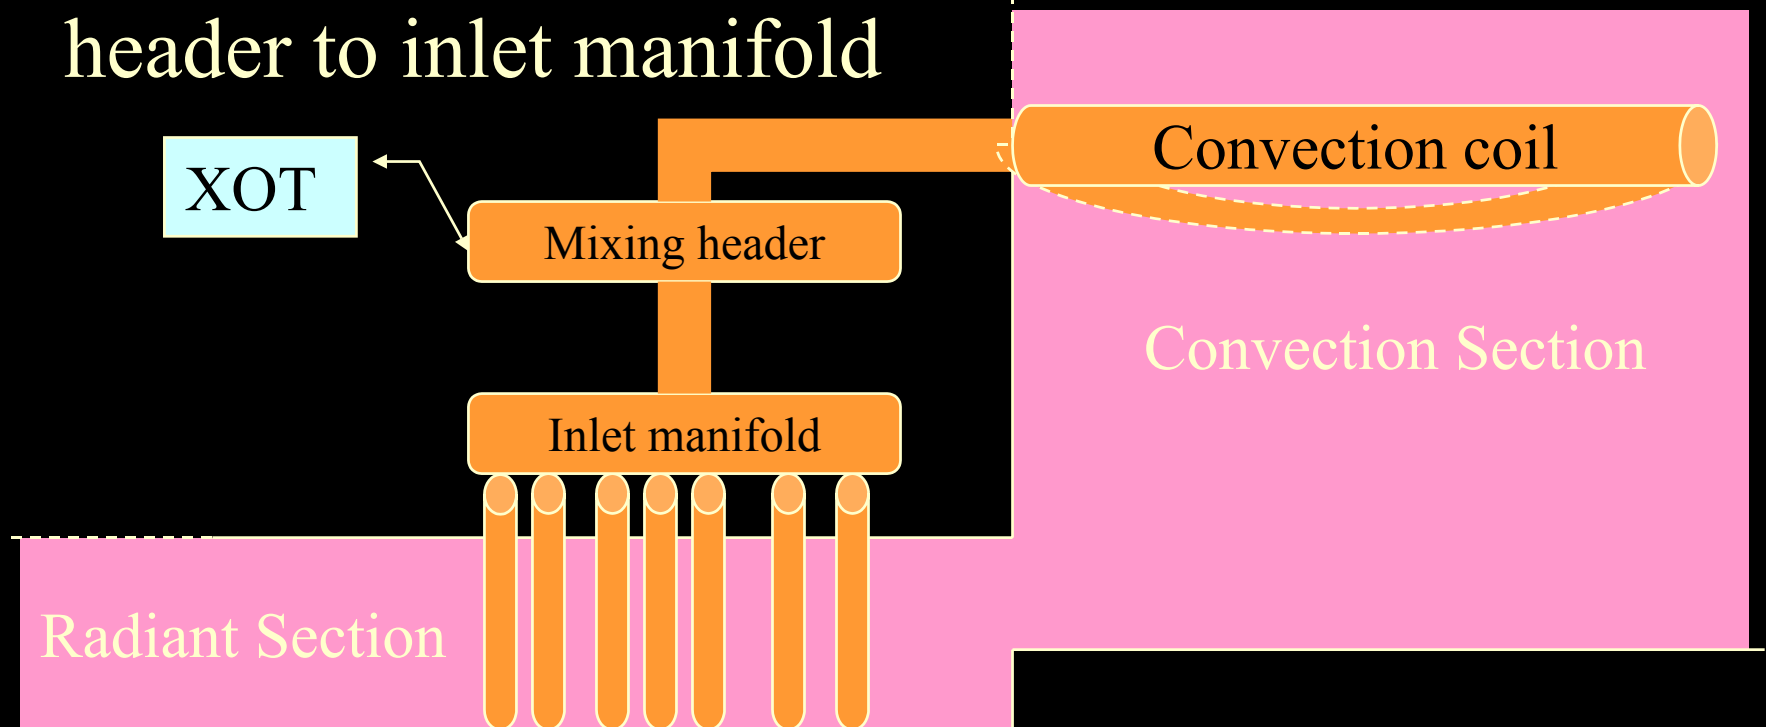
2nd Opportunity : Convection Coil Bowing - scenario

- Bottom section of convection bank bowed approx. 30cm
- Cracks at weldment from mixing header to inlet manifold

- Zone mainly recycle feed
- Recycle cracking requires higher Coil Outlet Temperature for conversion
- Excess heat recovered in convection

- Too much excess heat raises XOT temperature which initiates premature cracking
- Metallurgy limits promotes creep and expansion

- Stress analysis required on piping and full understanding of metallurgy limits
- Spring hanger adjusted to relief piping stress
- Bowed convection coils replaced
- Secondary steam injection optimized

- Upgrading of crossover and convection material
- protect convection coils by insulative material

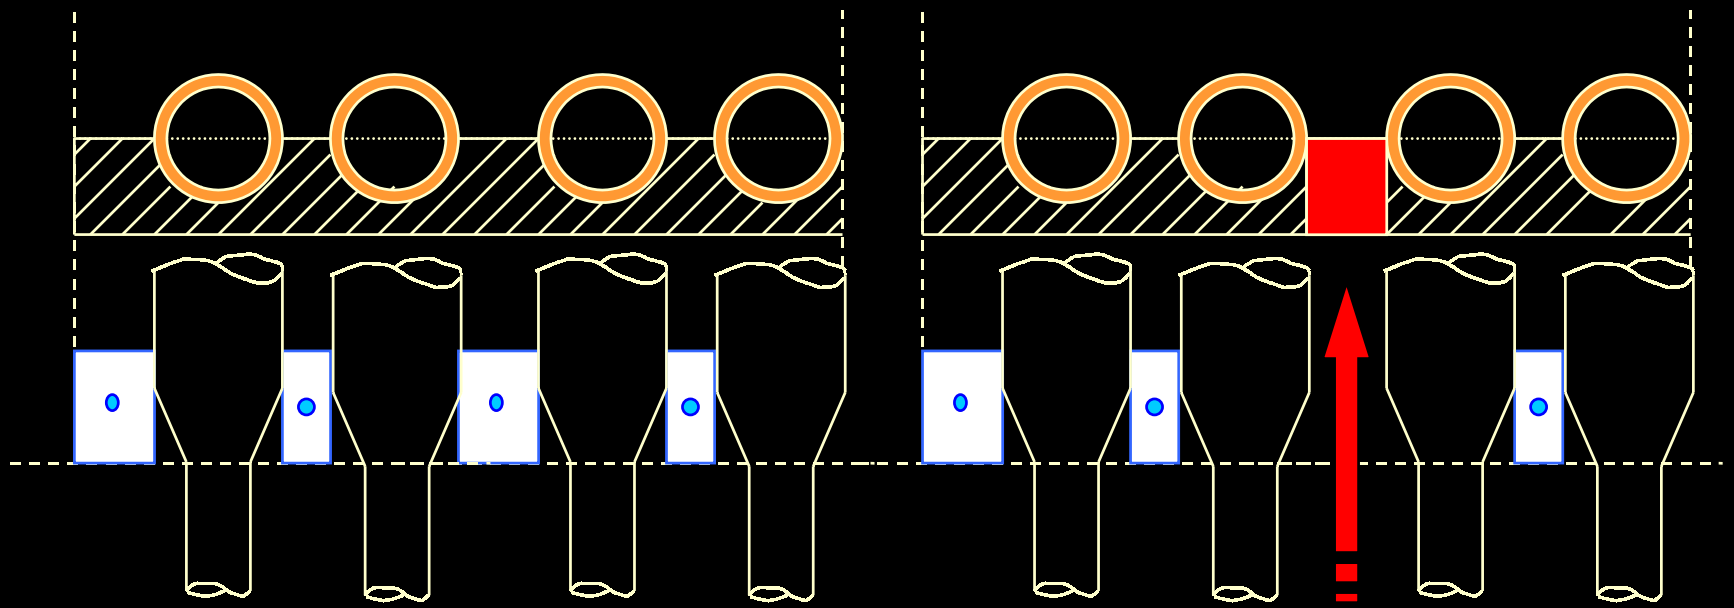
- Plates deteriorated and warped
- Some insulation cladding melted
- Insulation material noticed on firebox floor

Shadow Box Hotspots - theory

- Heat escaping shadow box due to improperly installed insulation
- Gaps existed which allowed heat to escape the radiant box

- Insulation stuffed from outside and inside
- Reengineer installation procedure and shadow box plate

- Final assessment of insulation integrity must be carried out each time furnace insulation replaced

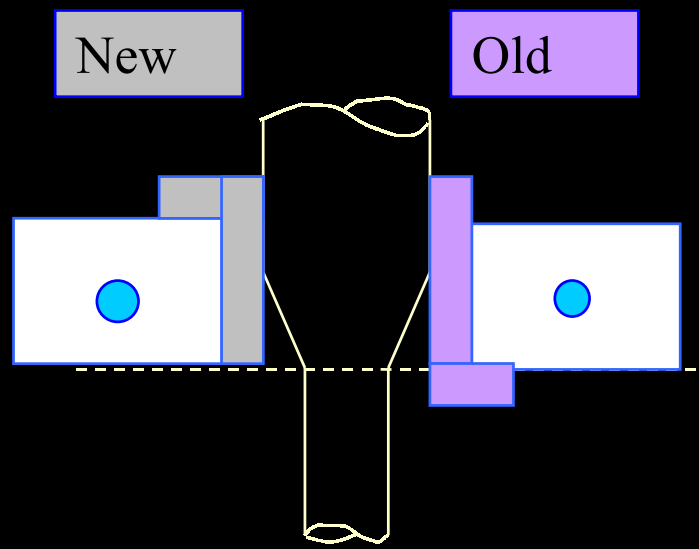
- Insulation around radiant outlet replaced and shadow box plates upgraded to SS304 after turnaround
- Hotspots detected on shadow box during thermograph survey

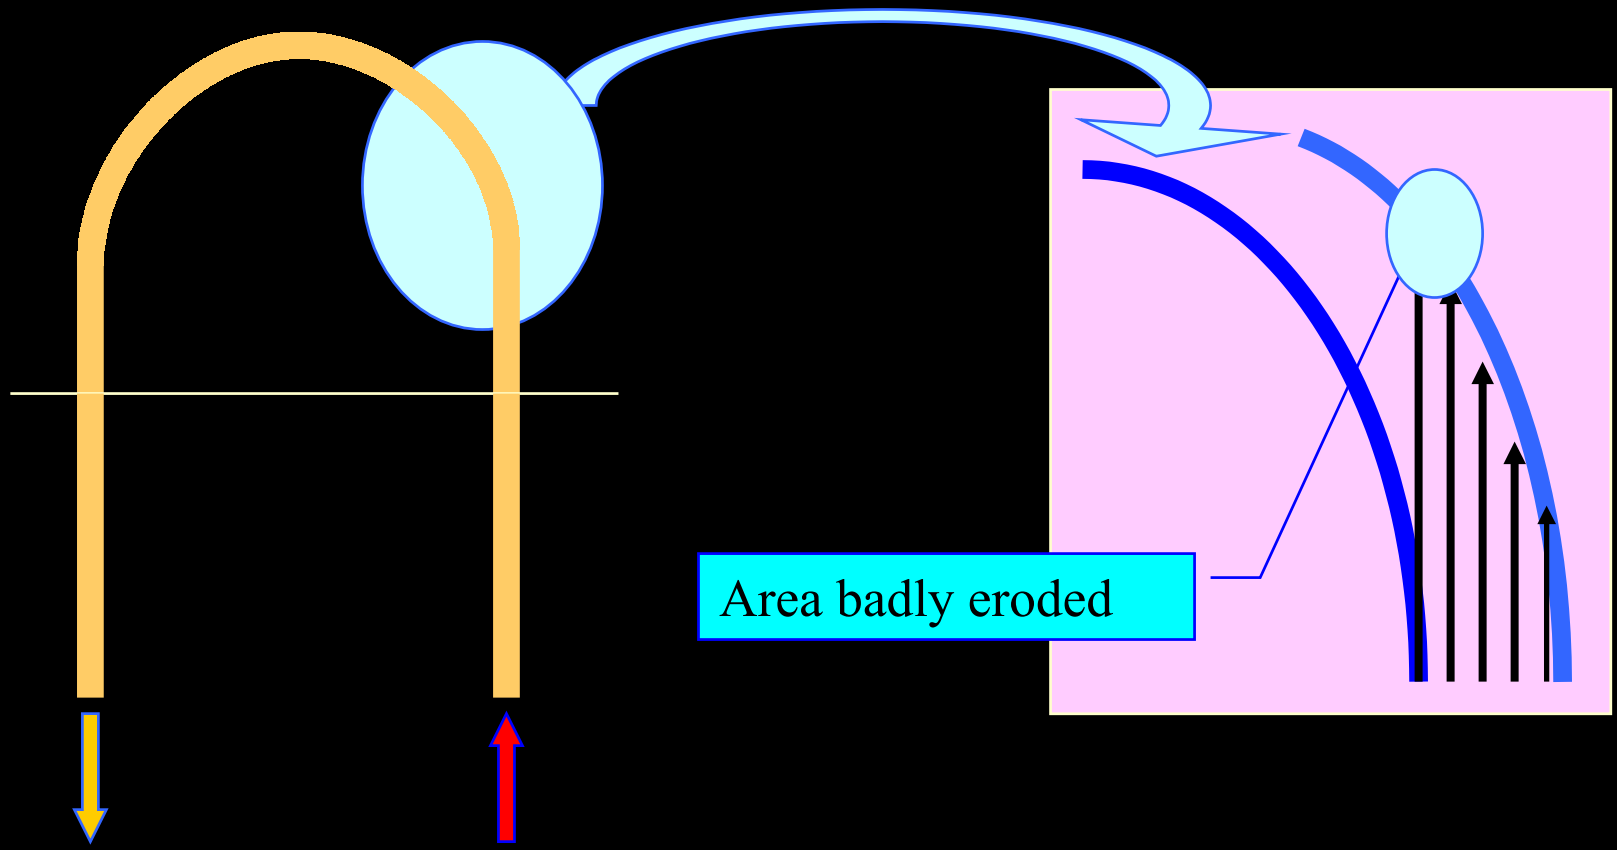
- Thinning 1mm per year at the inlet sweep bend
- Change U-bend if thickness drops below 3.5 mm from initial of 8.8mm
- Replacement every 3 years

- Erosion main contributing factors include solid presence, material specification and flow path geometry
- Initially, gradual transition in flow section and shallow-angle intersections was enough to mitigate erosion

SLE U-Bend Erosion - theory

- Inlet and outlet sweeps alternated to even out erosion effect
- Ultrasonic Thickness Scanning (UTS) to detect thinning and make replacements
- Modify U-bend to increase integrity of pipe inline with increasing flow turbulence

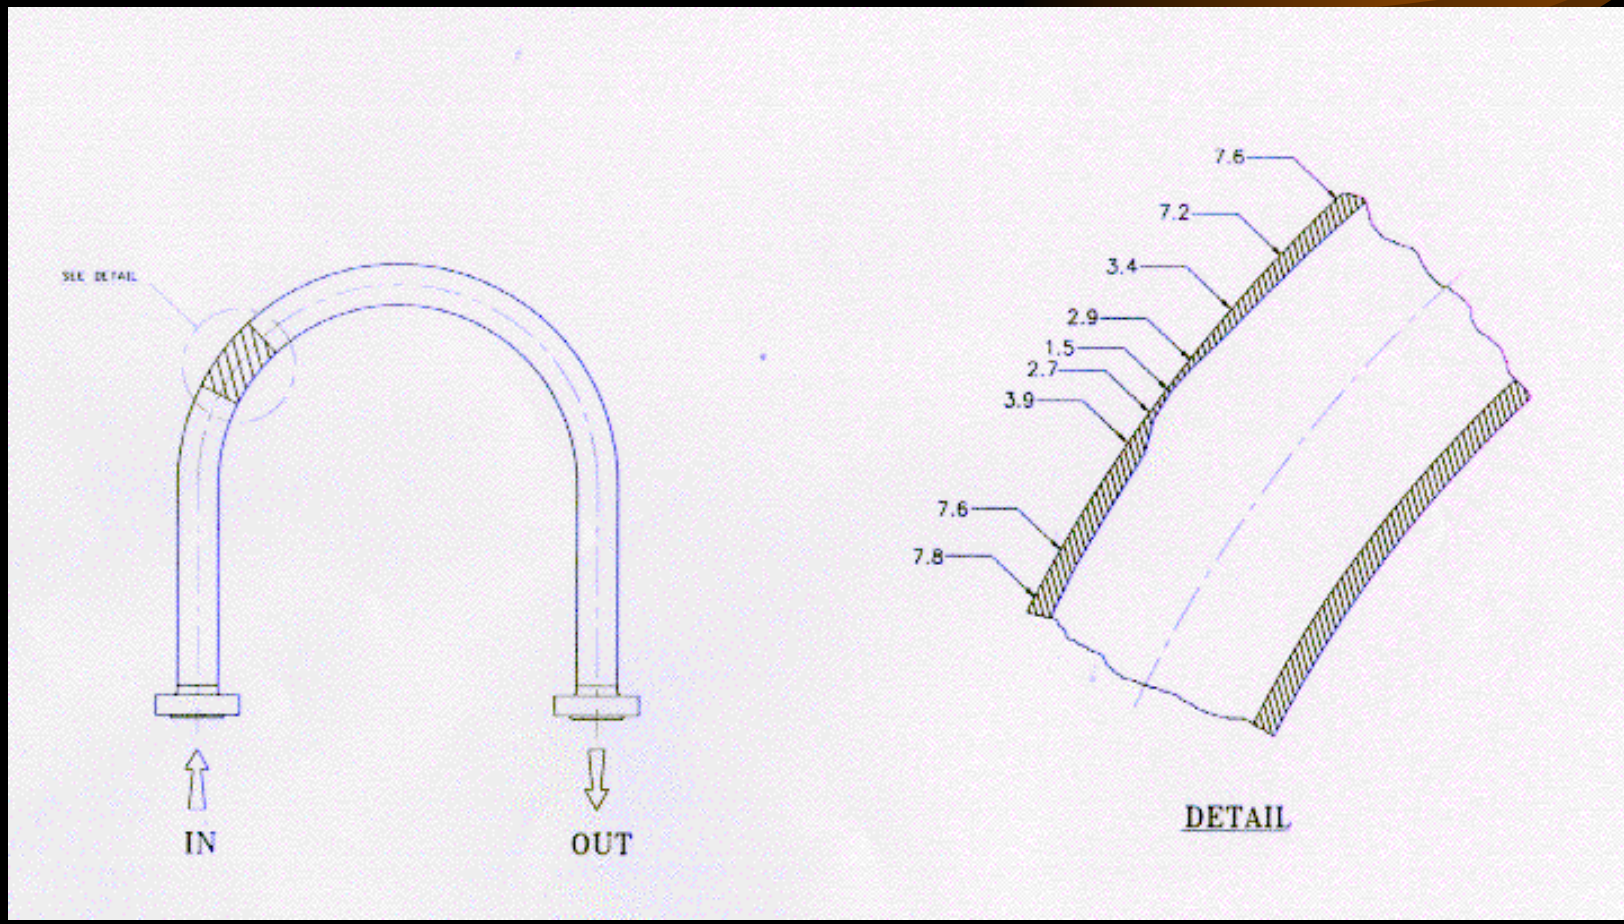
SLE U-Bend Erosion - theory

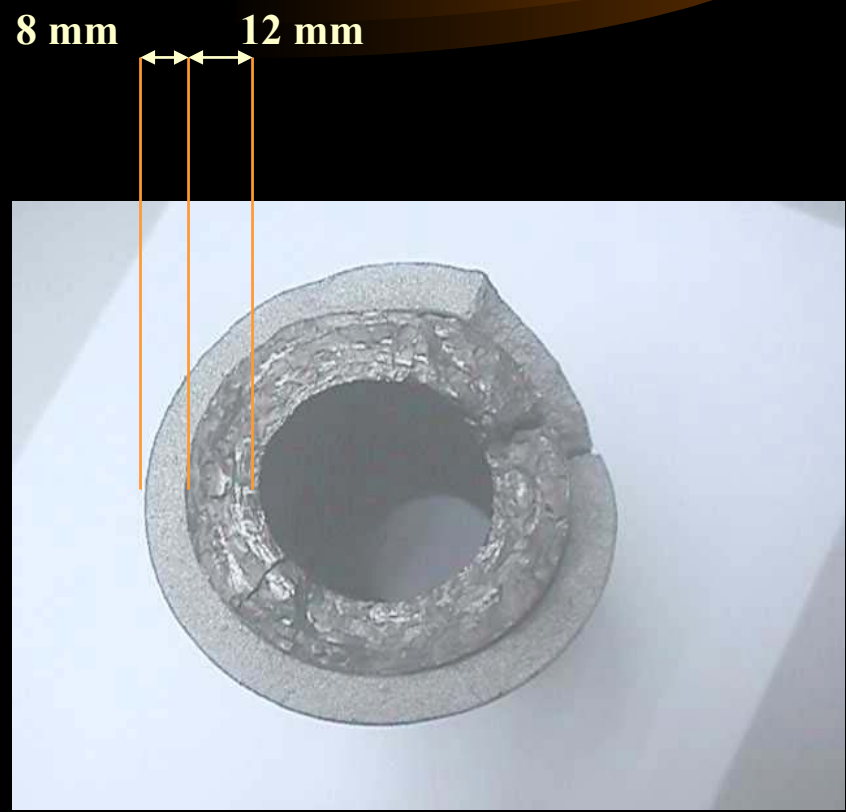
Radiant Coil Thermal Shock -theory

- The coke layer can reach > 10 mm thickness depending on the type of feedstock and severity

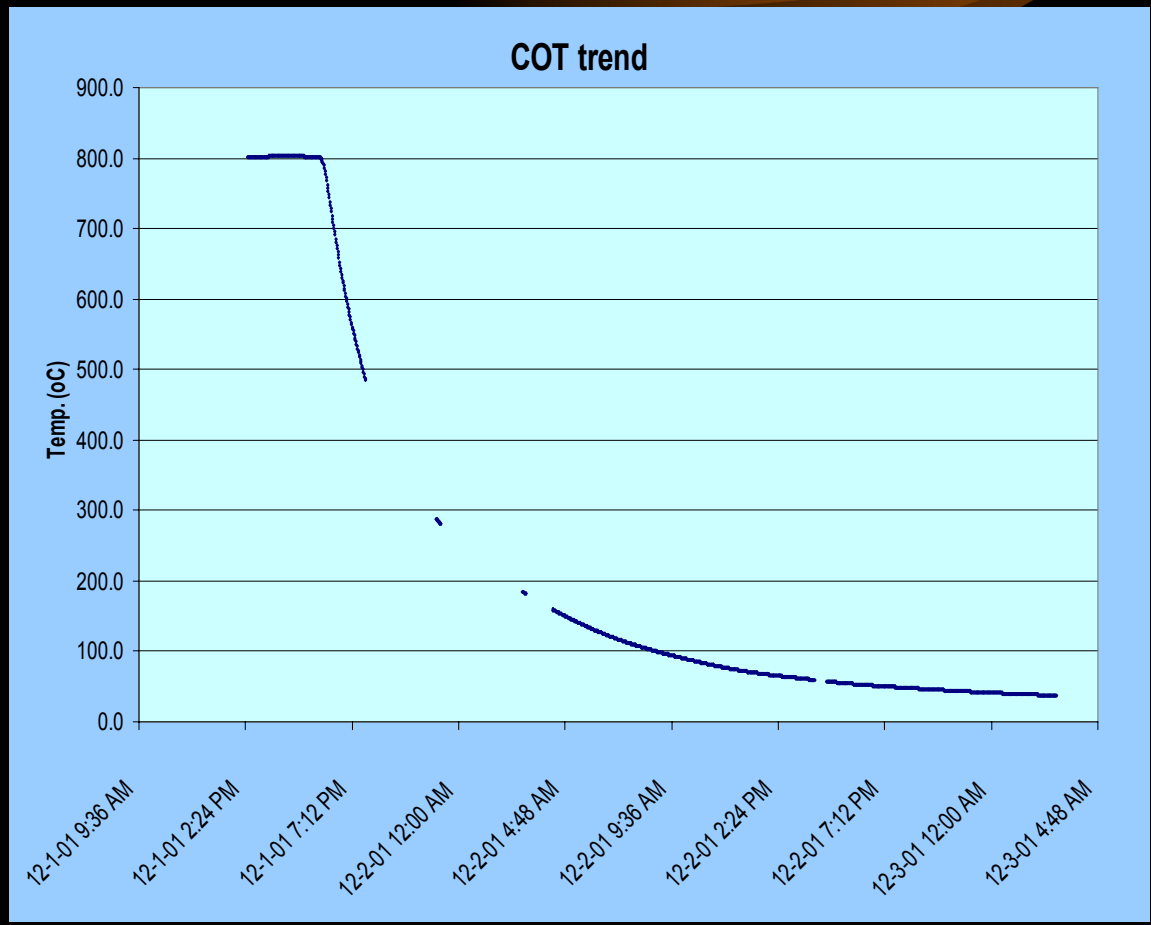
Radiant Coil Thermal Shock -scenario

- Coil temperature drops 100 ~200 °C in 1st hour after trip
- Allowable temp. drop is <80 °C

- Difference in cooling rate depends on amount of coke and insulation condition
- Coils inspected after temperature almost ambient : ~ 70 coils needed replacement

- Decoke End Of Run tubes as soon as possible before shutting down furnaces
- Avoid unnecessarily furnace emergency shutdowns
- Ensure reliability of Uninterrupted Power Supply (UPS)
