**FLARE LINE FAILURE CASE,  
WHAT HAVE WE LEARNED?**

Abram Kuo  
Ryan Pitt  
Westlake Group  
900 Hwy 108  
Sulphur, LA 70664

Prepared for Presentation at the 2004 Spring  
National Meeting, New Orleans, LA  
April 25-29  
16<sup>th</sup> Annual Ethylene Producers' Conference  
Session T8001 – Ethylene Plant Safety

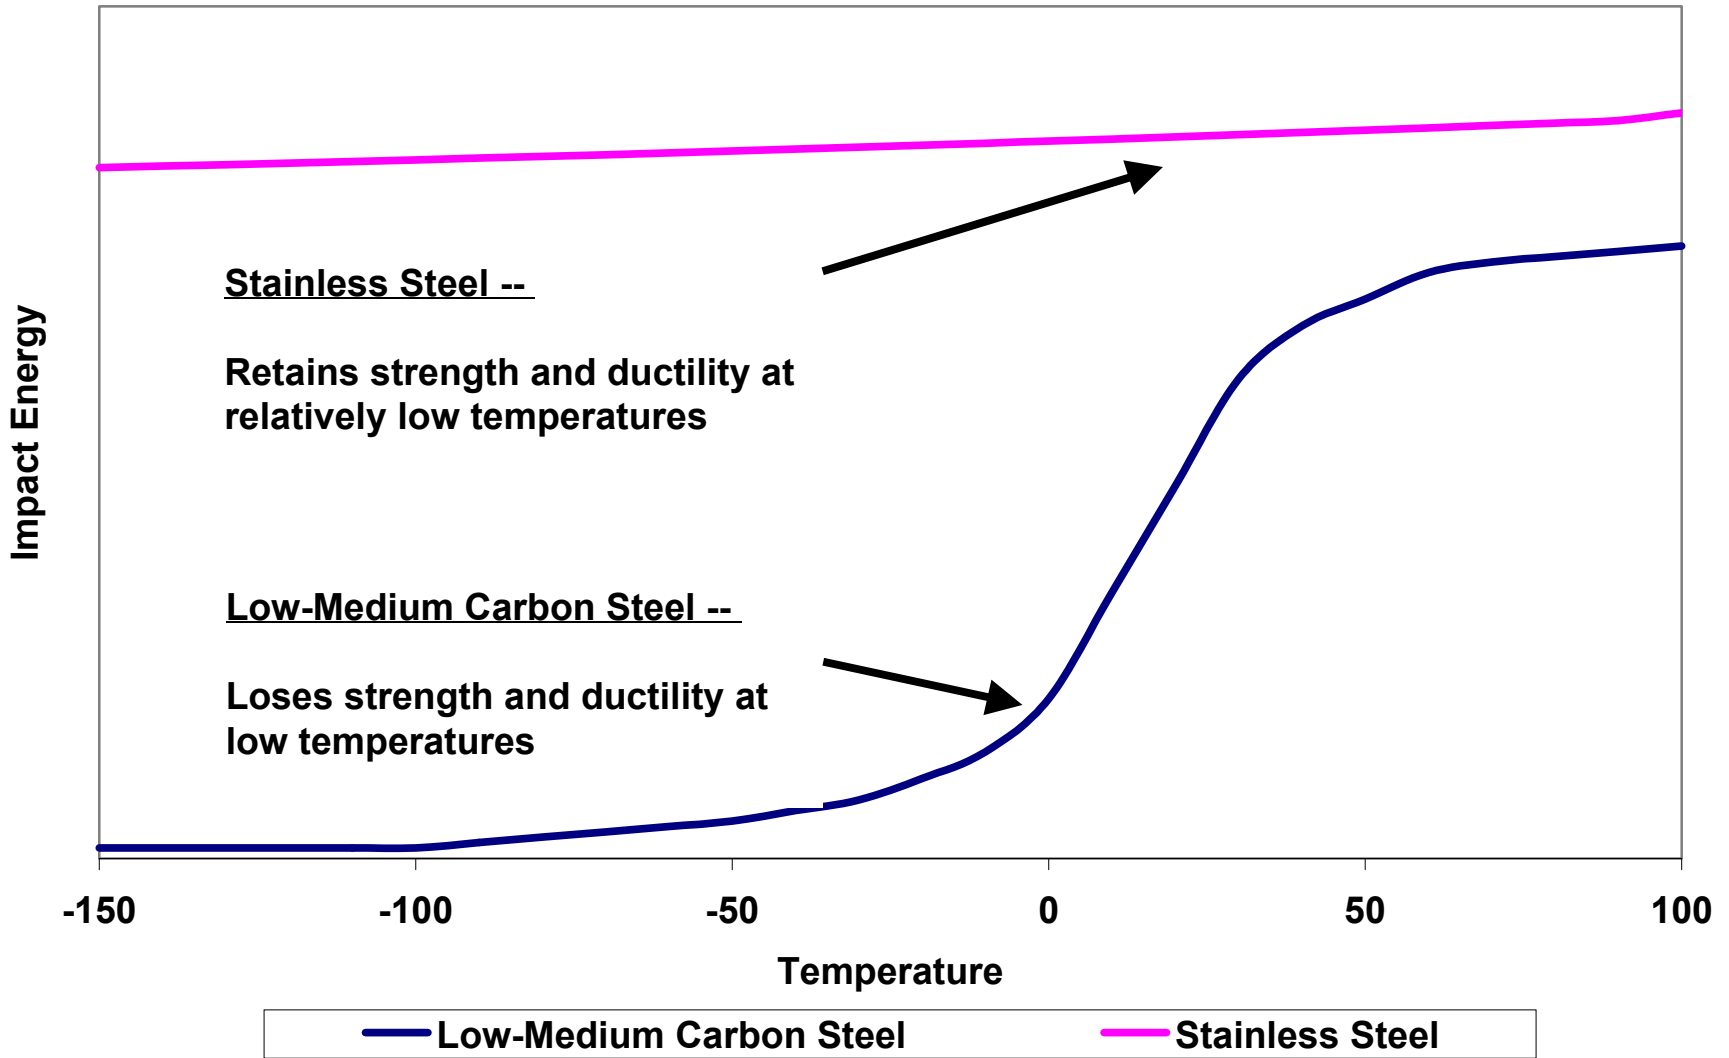
# Impact Energy vs. Temperature for Carbon and Stainless Steel

- Carbon steel piping is typically used in services w/ temperatures above -10 to -20 F
  - Impact testing can certify the use of carbon steel piping in services as cold as -55 F (i.e. “killed carbon steel”)
- At temperatures below -10 to -20 F normal carbon steel loses ductility and strength
  - The metal becomes brittle and can be susceptible to brittle fracture
- Three main factors influence the onset of brittle fracture:
  - Temperature
  - Flaw size (notches, scratches, etc...)
  - Stress
