*Ethylene Unit Pyrolysis Furnace  
Opportunity  
& Strategic Improvements*

# *Pyrolysis Furnace Opportunity & Strategic Improvements*

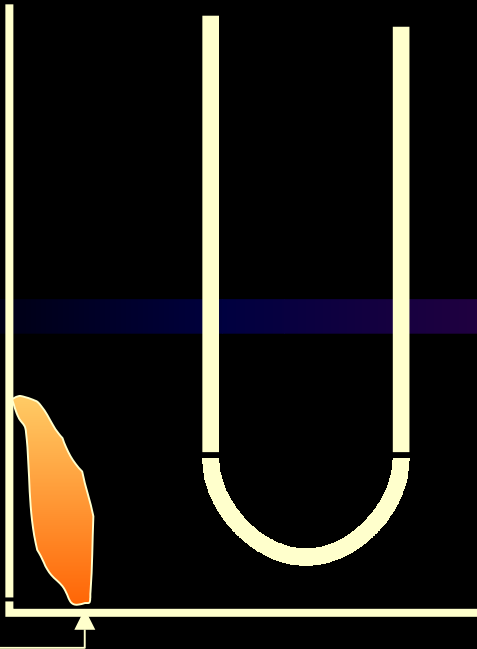
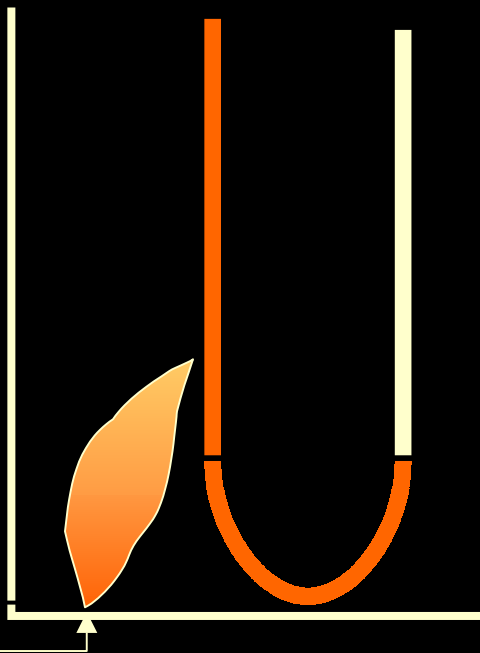
- Creep rate is between 60 - 78 mm per year in one zone example
- Coil needs shortening approx. every 5 years
- Recycle zones are fired harder to achieve optimum yield causing higher Tube Metal Temperature (TMT)

- Flame impingement
  - burner tip blockage
- Heat maldistribution
  - uneven firing
  - mixture of old & new burner tips
- ASWT
  - average sound wall thickness
  - thicker walls more prone to creep

- Burner tip cleaning and maintenance
- Coil elongation monitoring
- Future:-

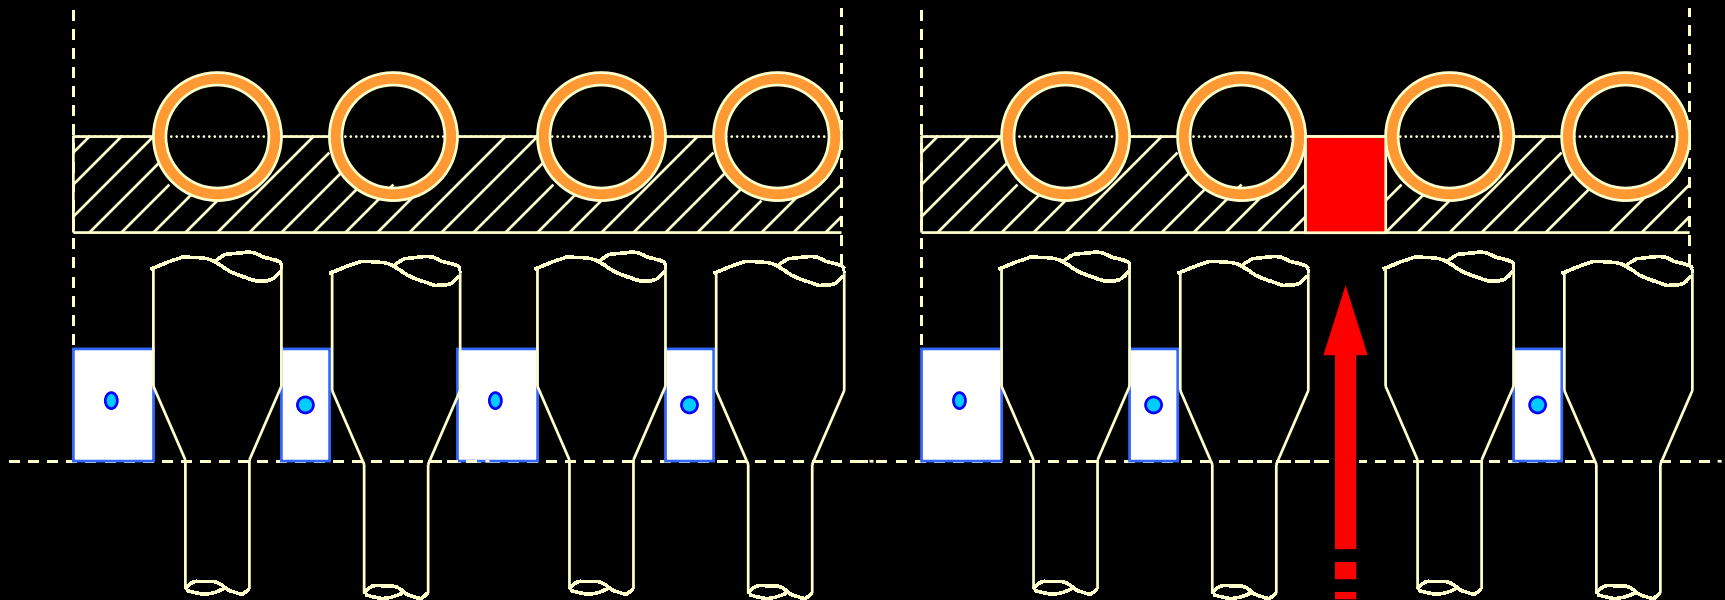
- Heat escaping shadow box due to improperly installed insulation
- Gaps existed which allowed heat to escape the radiant box

- Insulation stuffed from outside and inside
- Reengineer installation procedure and shadow box plate

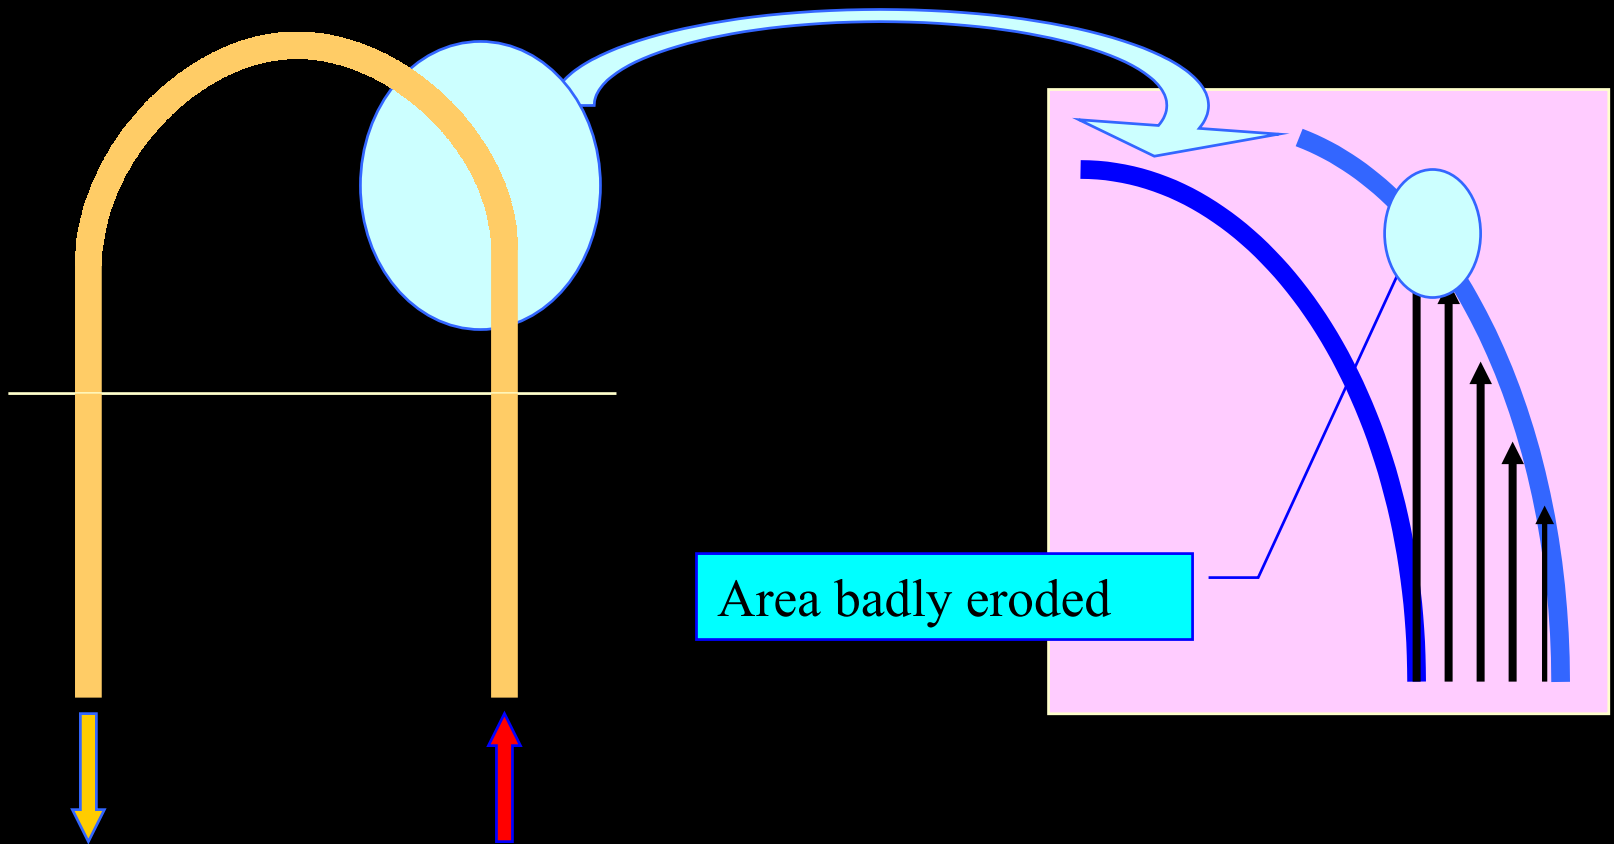
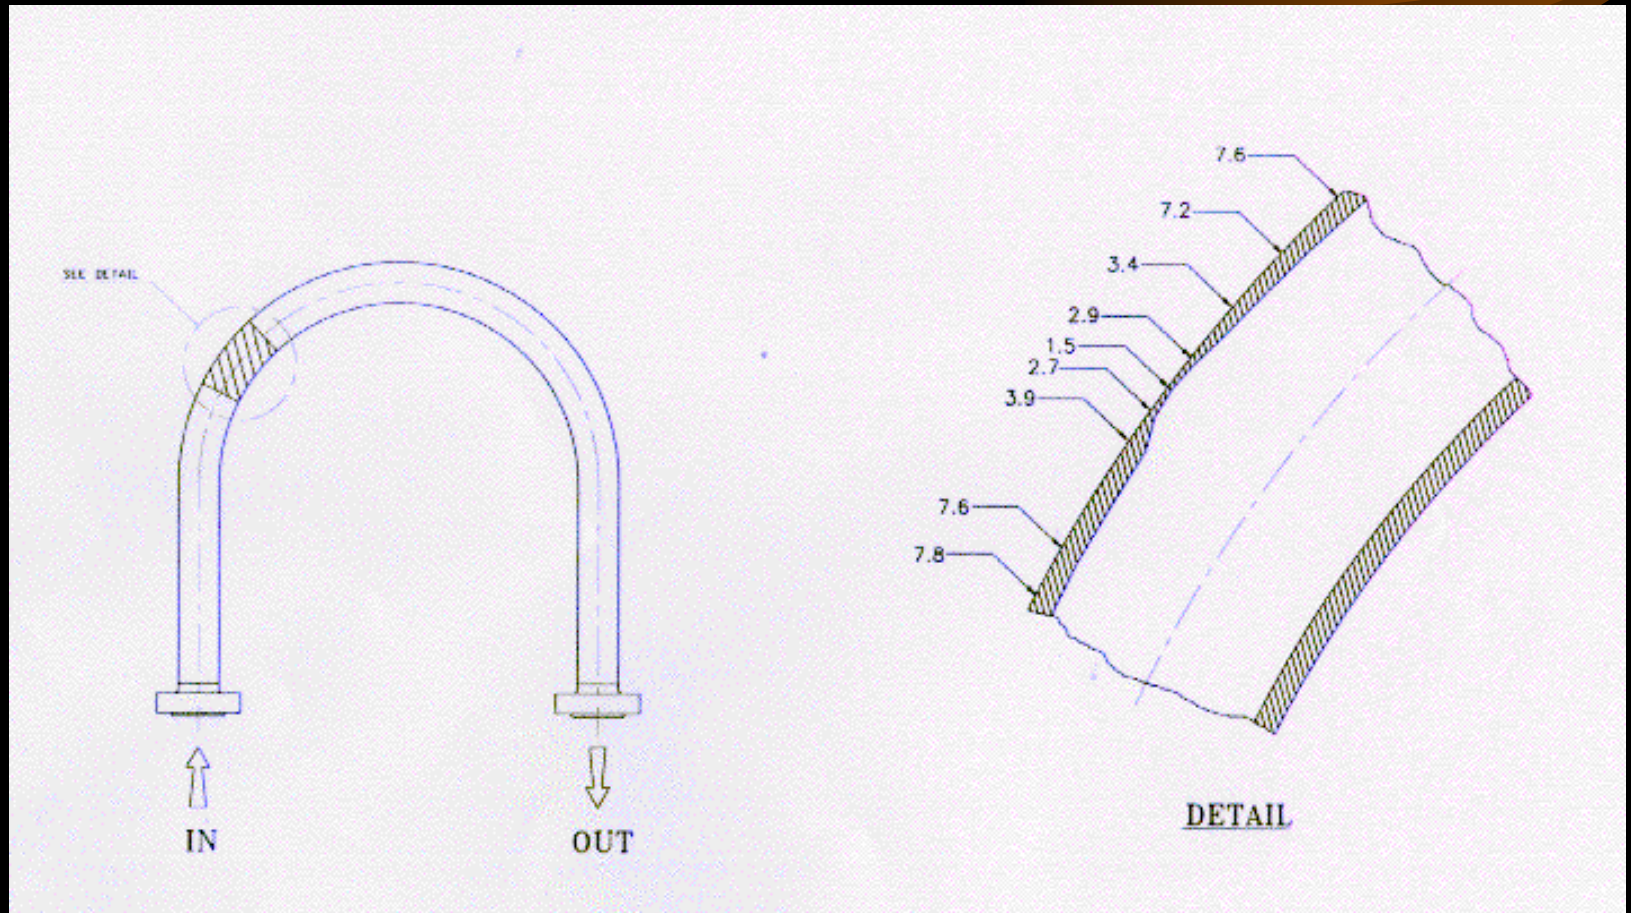
- Thinning 1mm per year at the inlet sweep bend
- Change U-bend if thickness drops below 3.5 mm from initial of 8.8mm
- Replacement every 3 years

- Erosion main contributing factors include solid presence, material specification and flow path geometry
- Initially, gradual transition in flow section and shallow-angle intersections was enough to mitigate erosion

- Inlet and outlet sweeps alternated to even out erosion effect
- Ultrasonic Thickness Scanning (UTS) to detect thinning and make replacements
- Modify U-bend to increase integrity of pipe inline with increasing flow turbulence

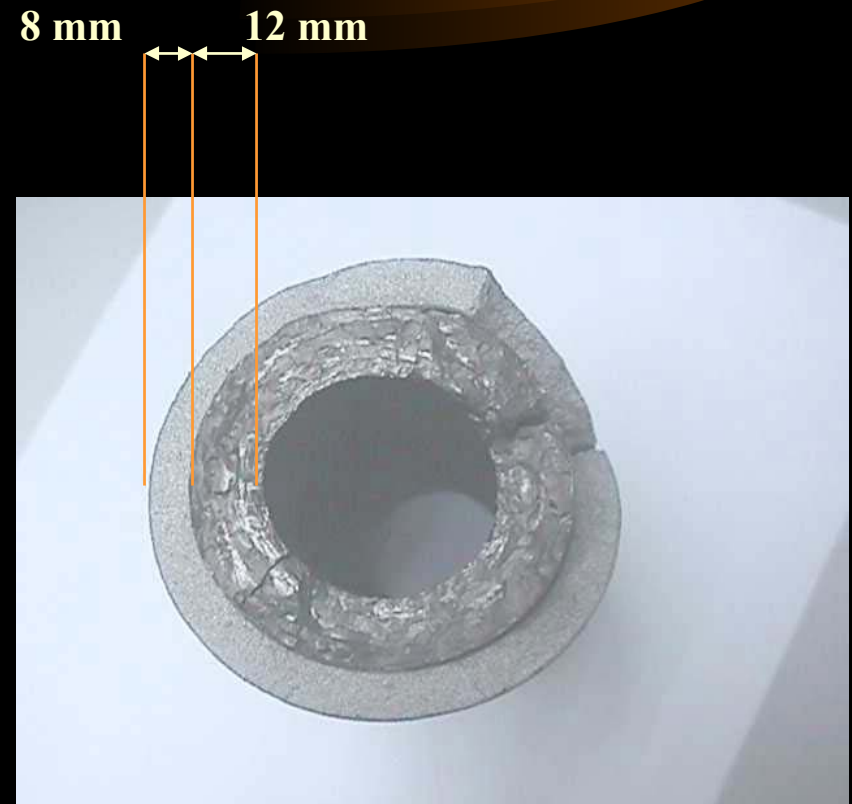
- The coke layer can reach  $> 10$  mm thickness depending on the type of feedstock and severity

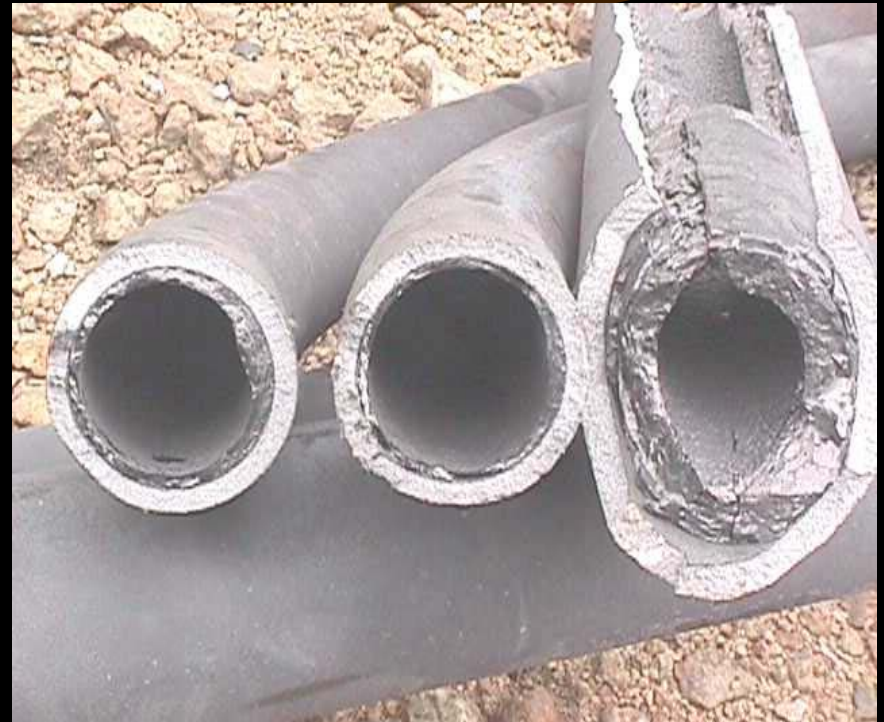
- The thickness of the coke is a function of the TMT
