Troubleshooting Practice in the Refinery

Andrew W. Sloley
The Distillation Group, Inc.
PO Box 10105
College Station, TX 77842-0105

Prepared for presentation at the
AIChE Spring National Meeting

23-27 April 2001

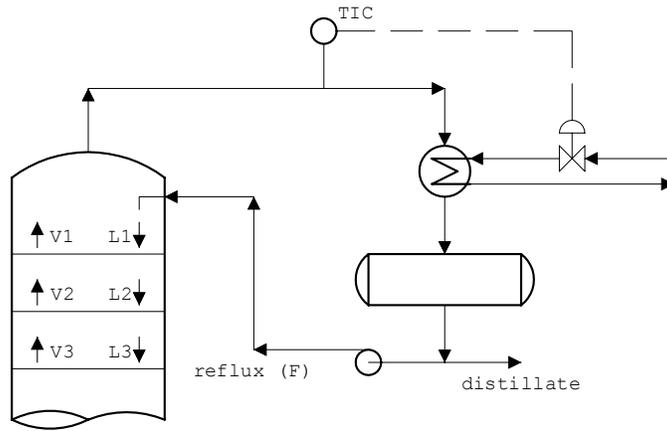
Figure 1
Subcooled reflux to tower

Referring to Figure 1, we see that L_F equals $L_2 - L_1$.

The introduction of subcooled feed into a column may cause operational problems and lead to premature flooding. If a subcooled reflux feed is going to be used, the effects of this stream must be accounted for in the design of the column.

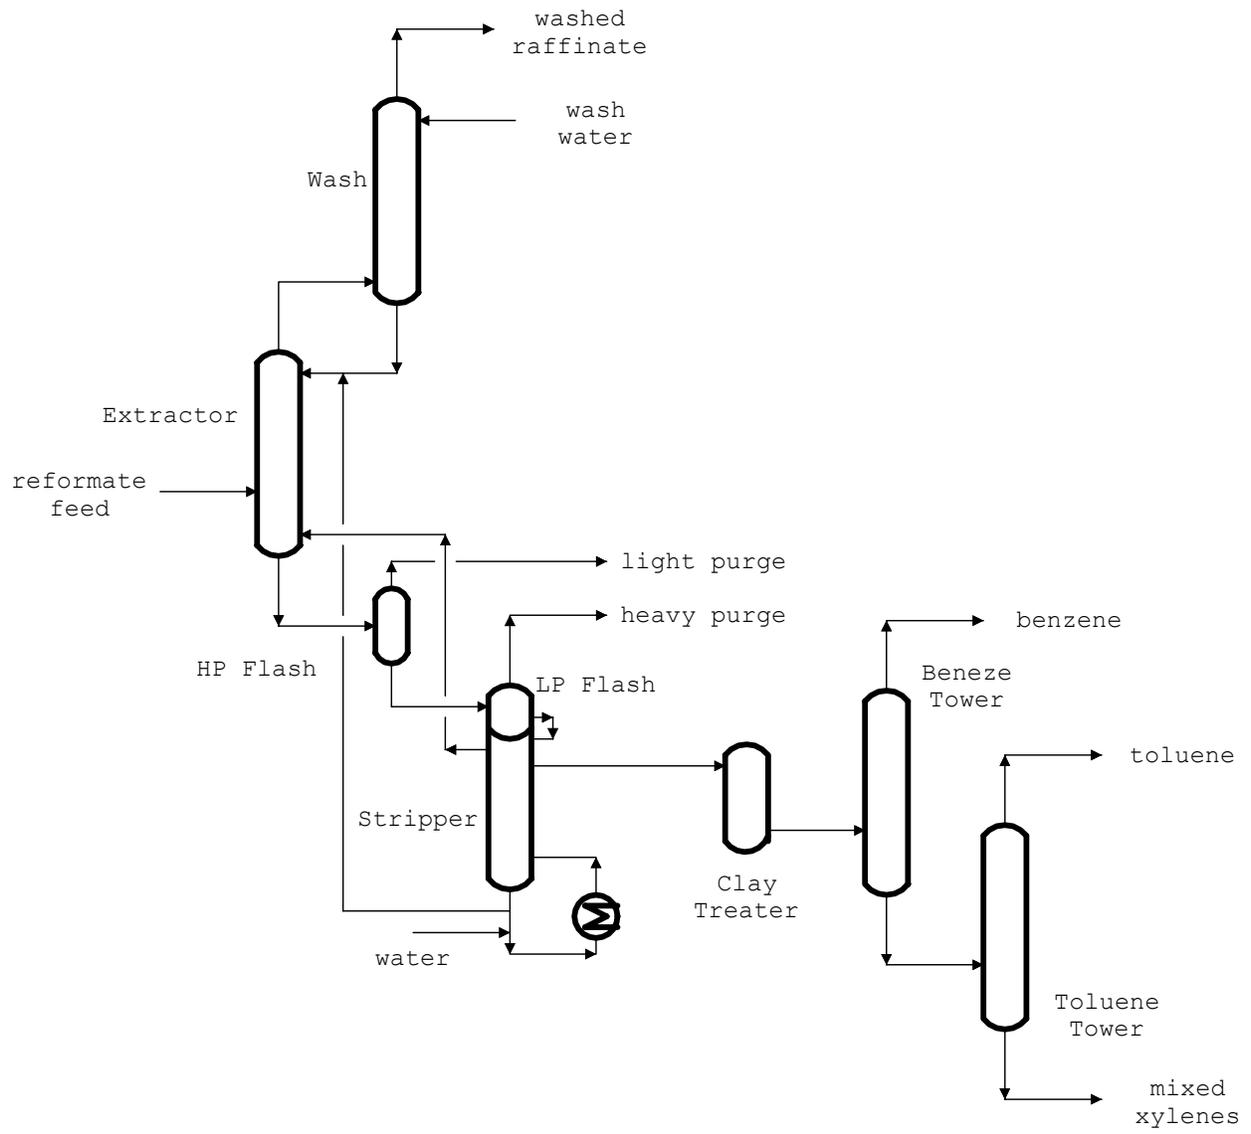
Figure 6
Aromatics Unit

In a debottlenecking study of a Texas BTX unit, the stripper tower was determined to be the unit limit. The unit was built in the 1960's and had under gone several previous revamps to increase capacity. The unit included a liquid-liquid extractor, flash drum, stripper tower, raffinate water wash tower, aromatics clay treater and three aromatic distillation towers (Figure 6).

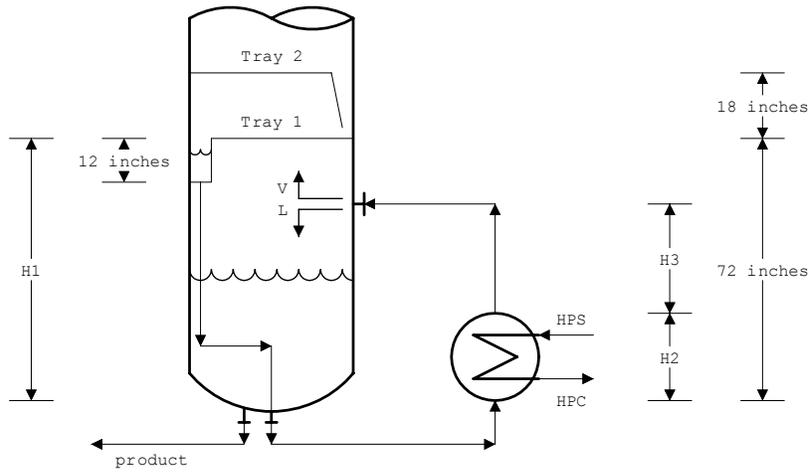
Figure 9
Once-through thermosiphon arrangement, before revamp

A petrochemical column was revamped with new trays. The column was a high-pressure service column (greater than 100 psig, 690 kpag). The column used a once-through thermosiphon reboiler for column boil-up. Before the revamp, the existing column arrangement had a feed pipe inside the column coming from a sump through the boot and then out the tower bottom to the reboiler feed line (Figure 9).

A once-through thermosiphon reboiler is classified as a natural circulation reboiler. Natural circulation is achieved by drawing liquid from the bottom tray and circulating it directly to the reboiler. The stream that returns to the column is partially vaporized. The net return liquid is recovered as bottom product (Figure 9) [5].

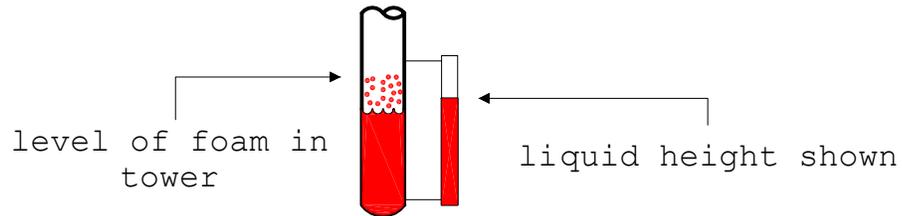
Figure 15
Foam and false liquid levels

Sight-glasses suffer from the same problem. A sight-glass reports back to the viewer the DP between the vessel taps as a height of clear liquid in the vessel. Sight-glasses, while valuable, must be used with care. Continuing the sight-glass analogy, looking at the exterior liquid reading gives us a lower liquid level than what the low-density foam inside the vessel really has (Figure 15). The control system has the same problem with DP cells. The density used to calculate a level is wrong and the controls allow foam to back over the trays in the tower.

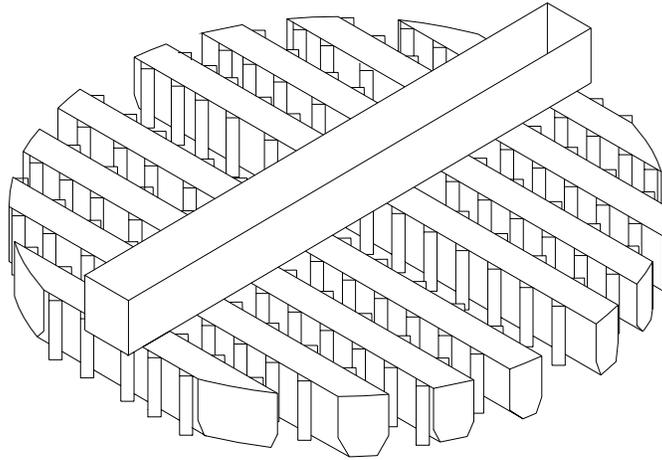
Figure 17
Trough-orifice distributor

There are many types of liquid distributors in commercial use. The most commonly used in fractionation services are the trough-orifice distributor (Figure 17) and the pan-orifice distributor

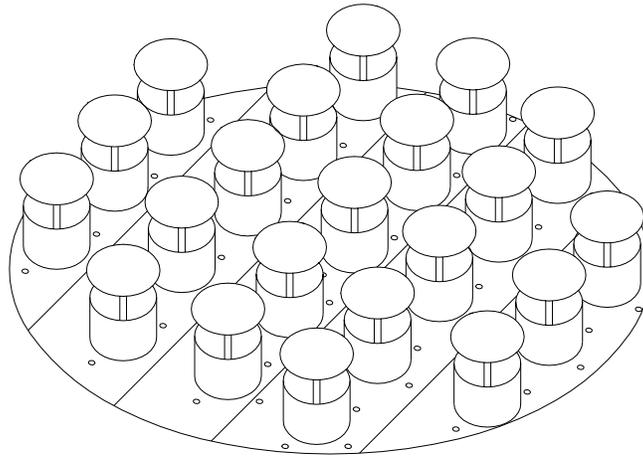
Figure 18
Pan-orifice distributor

(Figure 18). Both can suffer severe maldistribution problems. Both require proper design, fabrication and installation.

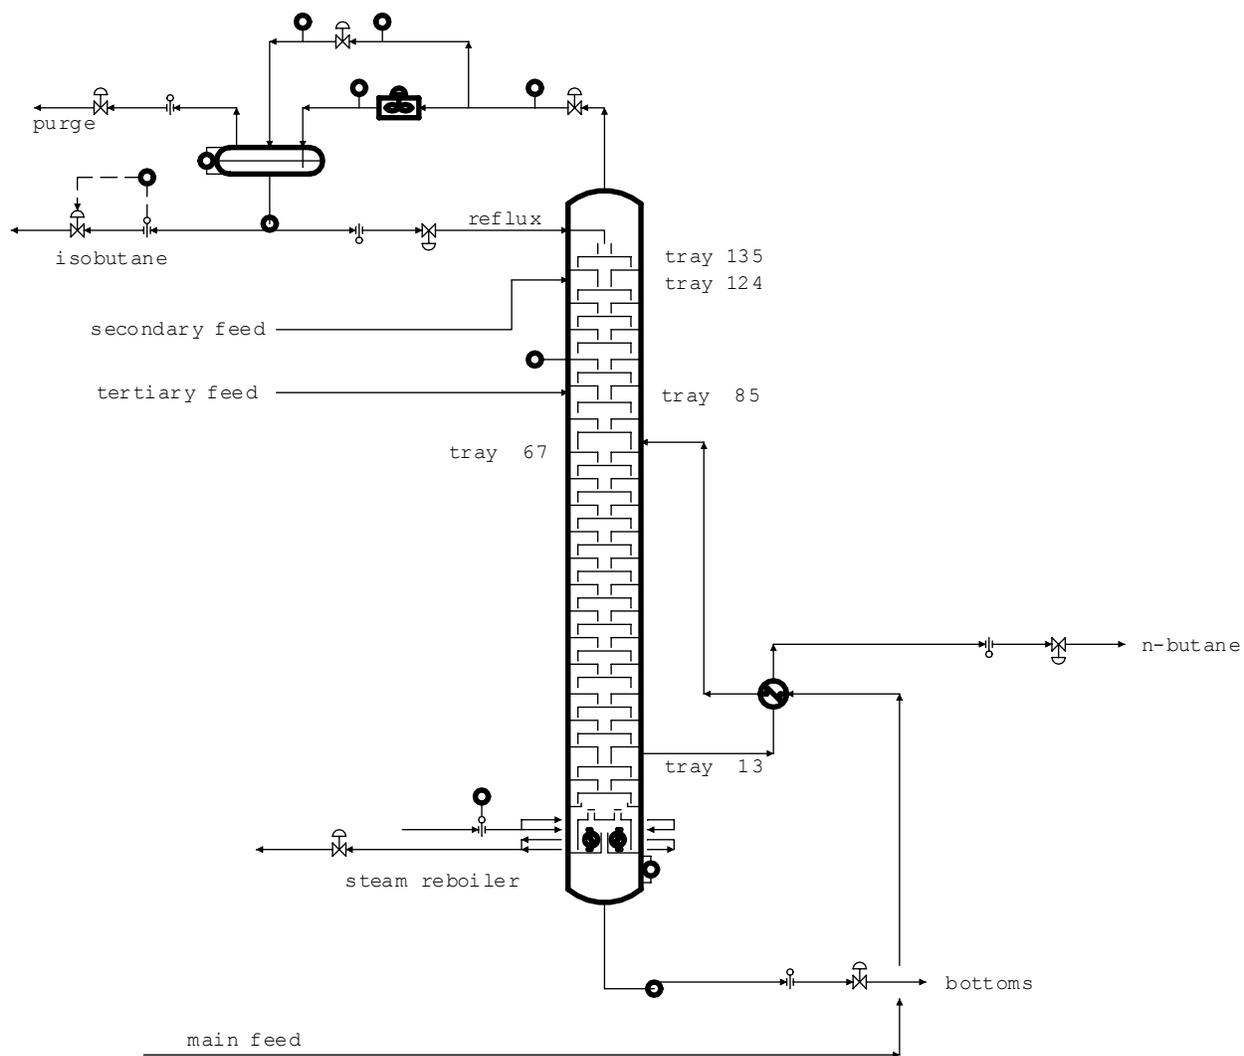
Figure 21
Deisobutanizer configuration

A petrochemical plant deisobutanizer suffered from control problems since start-up. The deisobutanizer had three feeds, a vapor distillate purge, liquid distillate product, vapor sidedraw product, and a bottoms liquid purge. The vapor sidedraw product was heat integrated against the unit feed. Figure 21 shows the unit configuration.

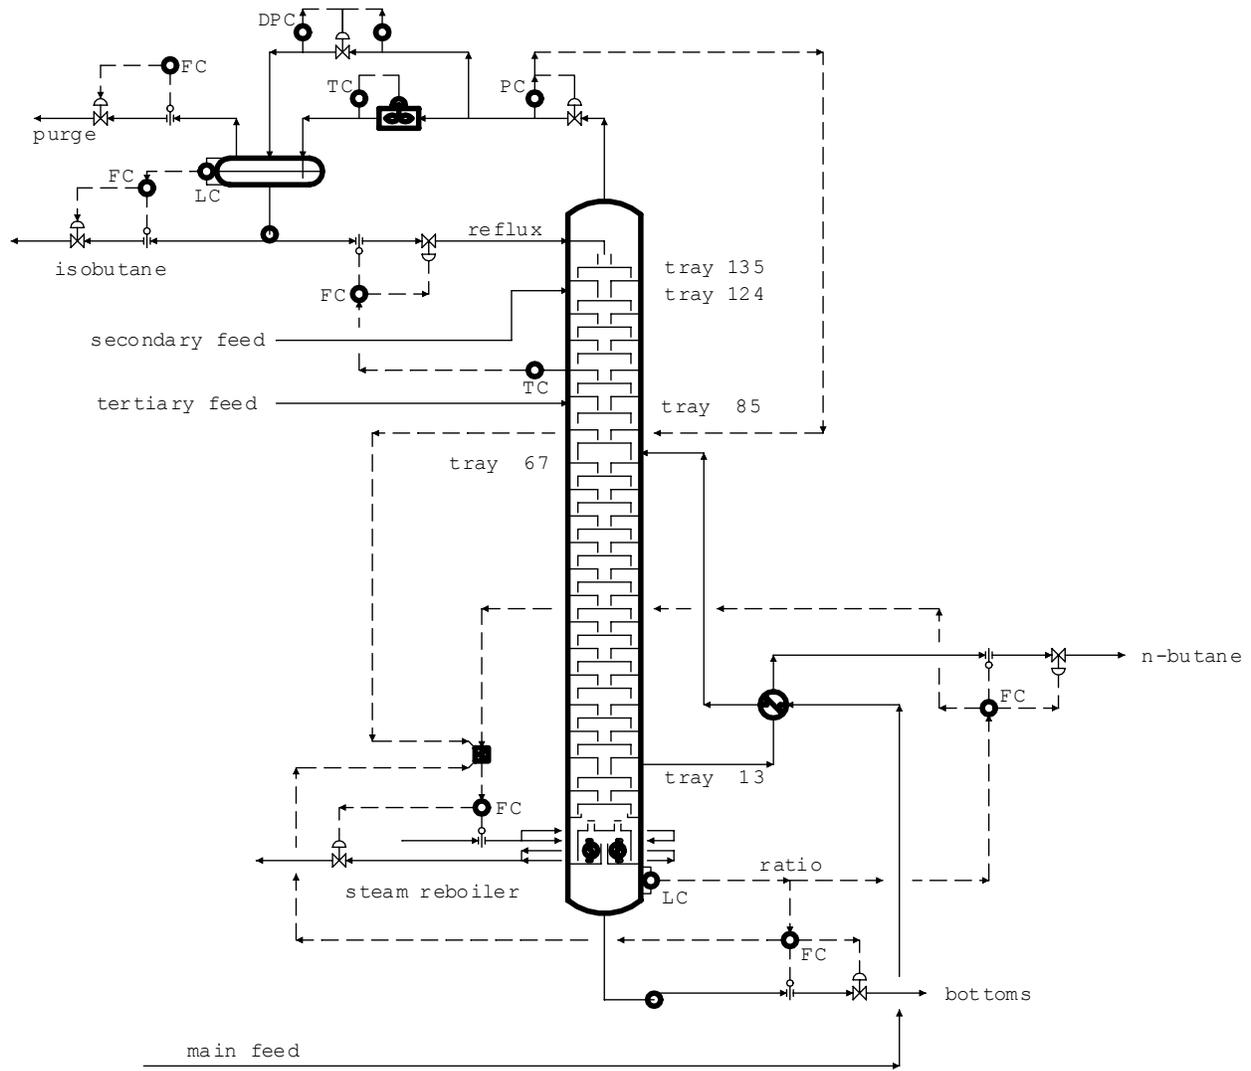
Figure 22
Original control scheme

Figure 22 shows the overall control scheme for the tower. Feedforward and feedback connections to other parts of the unit are not shown. This complex control scheme for the tower never worked properly.

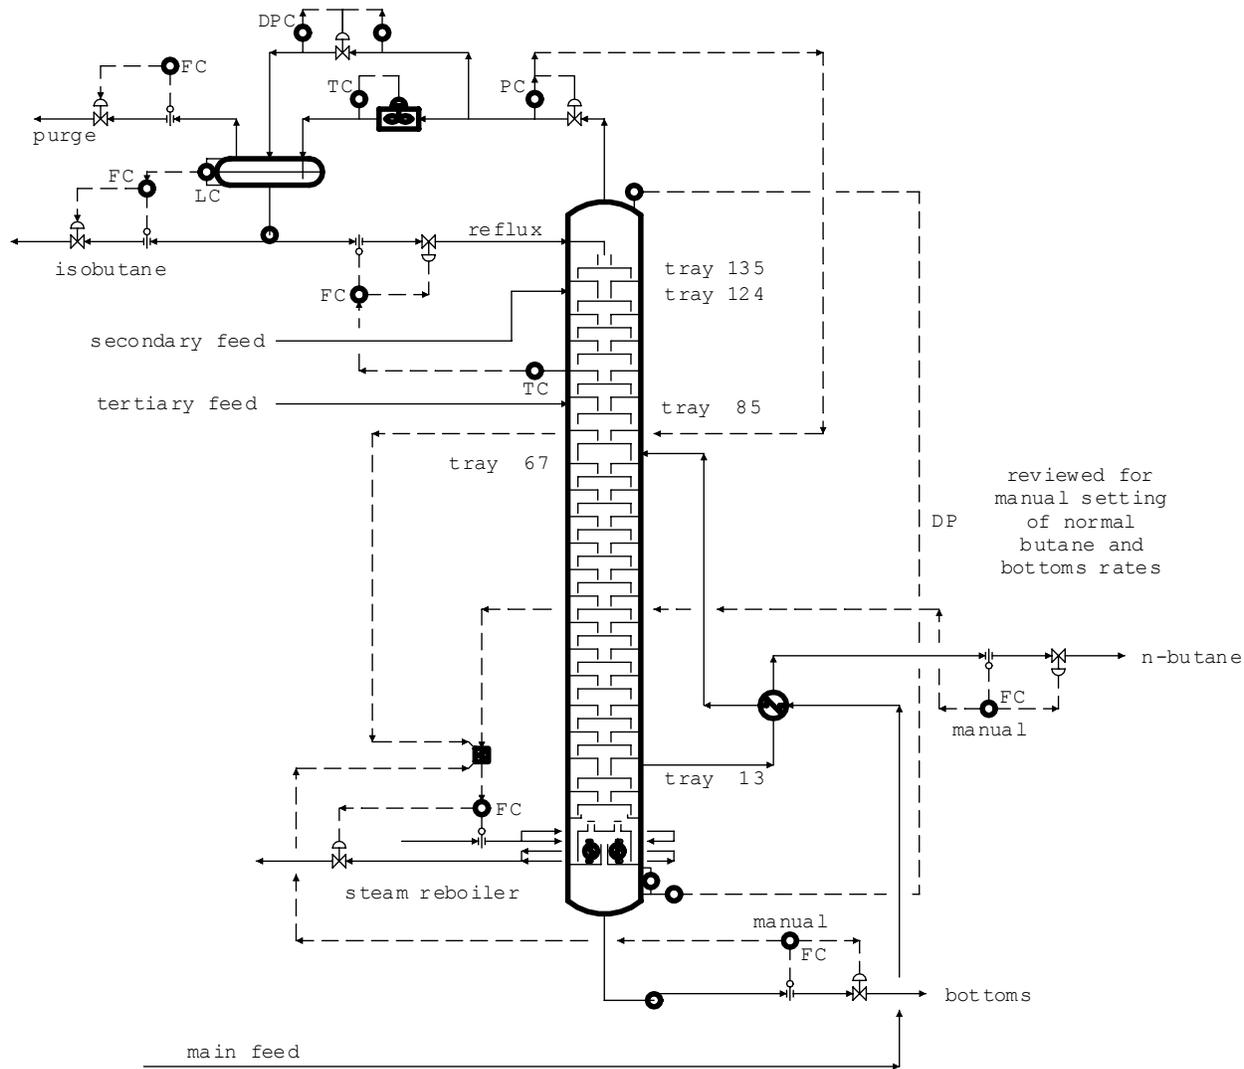
Figure 24
 DP cell added in attempt to improve bottoms level control

Second, a DP cell was added across the tower to attempt to predict bottoms level based on the pressure drop from the lower level tap to the top of the tower. The DP cell measured the liquid height in the boot plus the pressure drop across 135 trays (Figure 24).

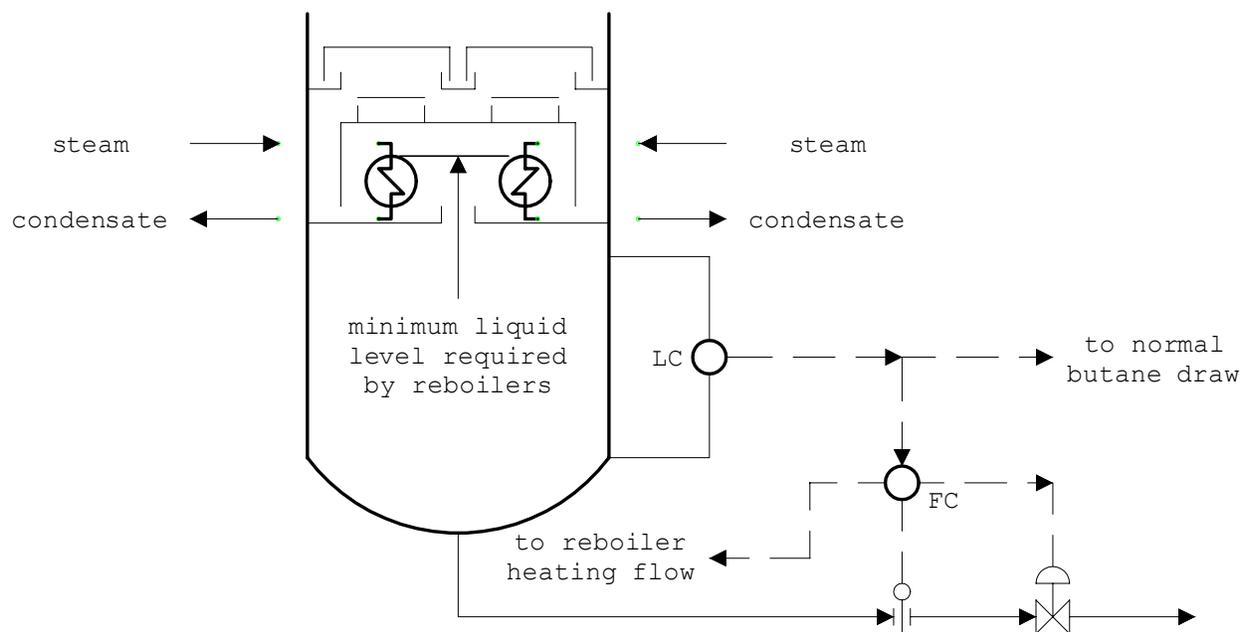
Figure 27
 Minimum liquid level required to make reboilers work

Only two rows of tubes in the reboiler bundles were wetted by the liquid held on the chimney tray by its outlet weir. With no liquid on the reboilers, heat could not be put into the tower. At startup, the operators had quickly discovered that deliberately running the tower above 100 percent of level allowed the tower to work. Figure 27 shows the minimum liquid level required to make the reboilers work.

- Raise the height of the chimney tray outlet weir to hold a liquid level on the exchangers
- Modify the level control instrumentation to use another type of instrument instead of a DP cell.

Due to the very low bottoms rate, less than one percent of the liquid traffic to the reboiler, the second choice, modify the level control instrumentation was selected. At the high liquid rates and with turbulence in the boiling pool around the reboiler, liquid overflowing the weir could be much more or much less than the bottoms rate required to purge heavies from the unit. The tower will continue to operate flooded to above the reboiler bundle levels. A gamma ray level detector is being installed to allow for full advanced control of the unit.

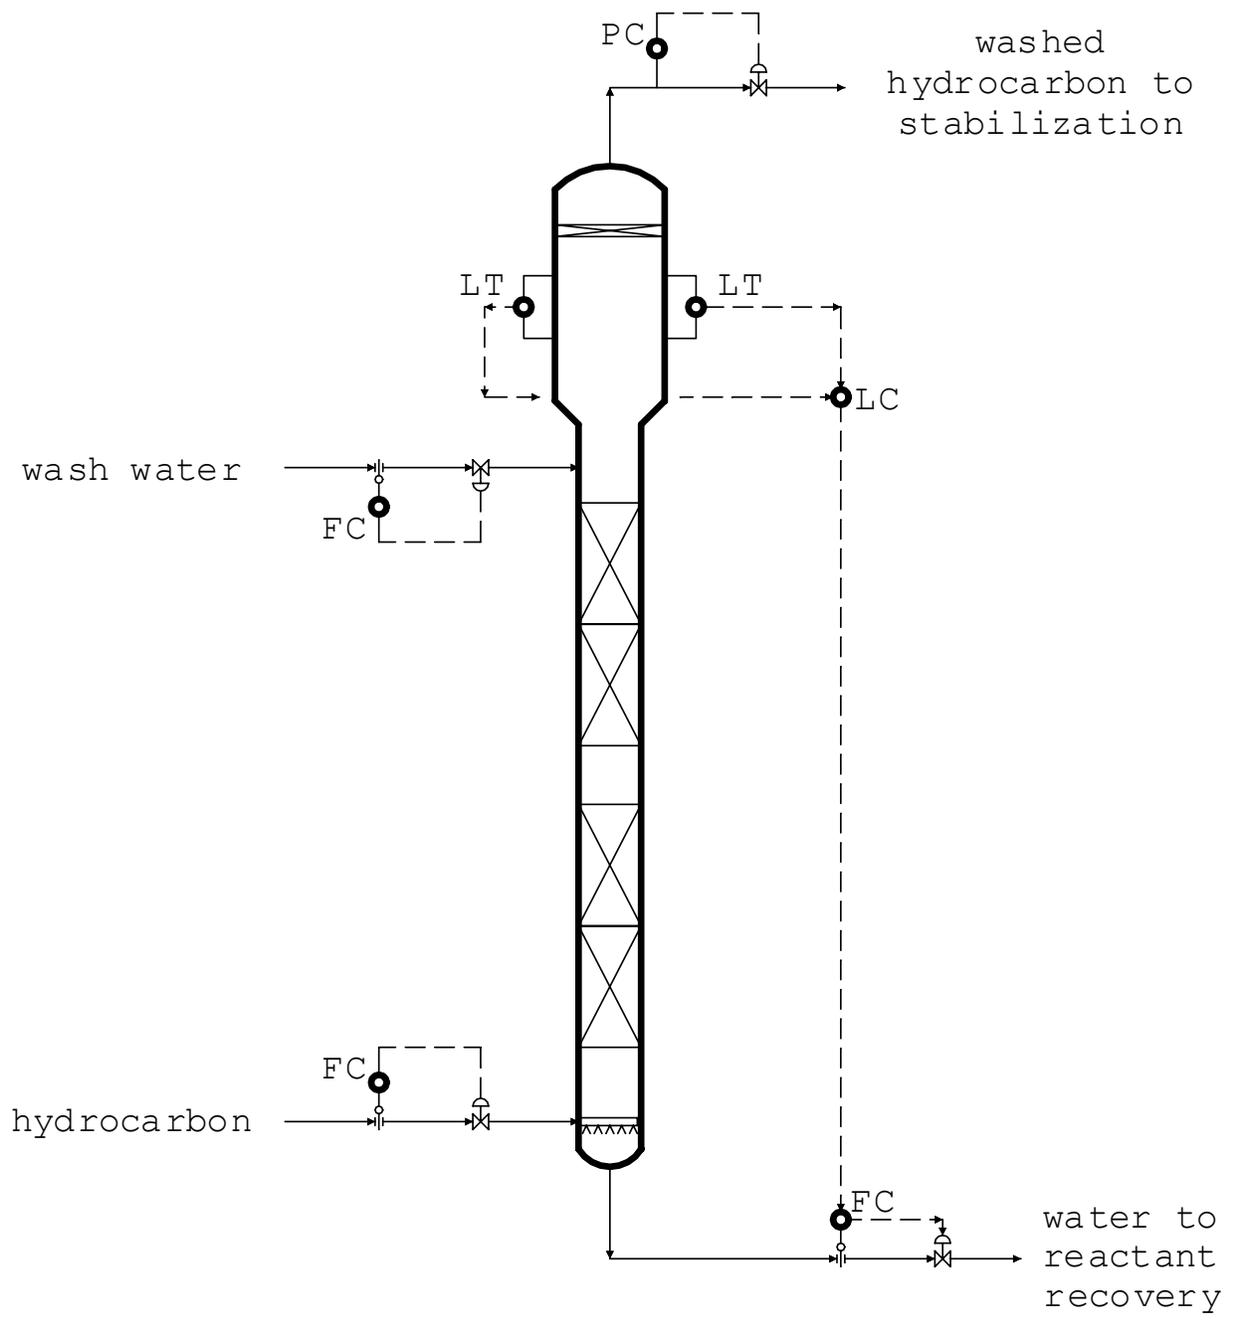
Figure 30
Water wash column

drocarbon in the water. Some fouling was tolerable, but after three years, entrainment began. Hydrocarbon entrainment caused operating problems. At the next shut-down the plant will return the hydrocarbon distributor to its original position.

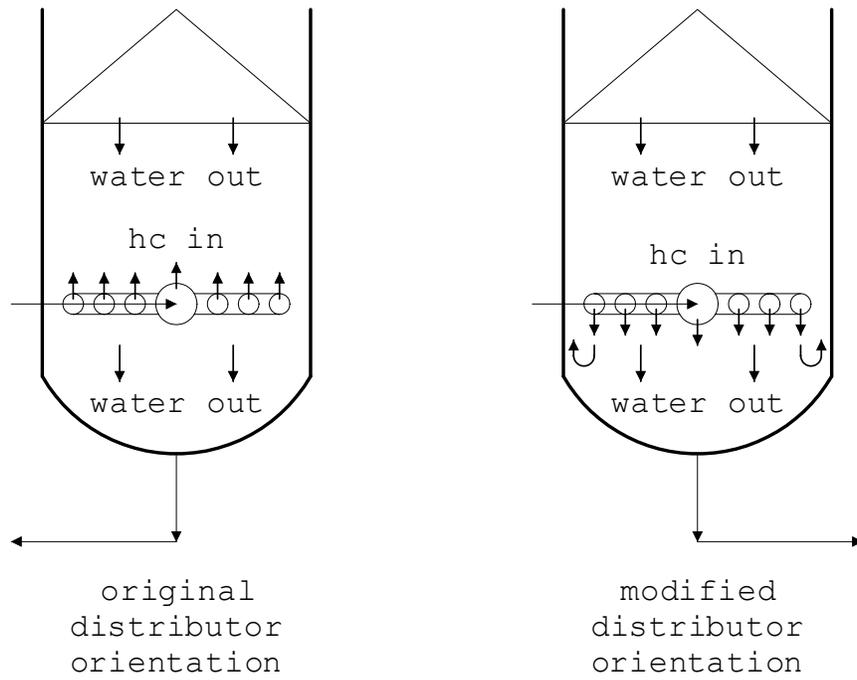
Figure 31
Rotated distributor

Normally, the orientation of a liquid-in-liquid distributor has minimal to no effect on extraction unit performance. Process engineers should always be open-minded about changes to improve operation. However, they should check the basis for changes and make sure that any risk from the proposed change does not outweigh its benefits. In this case, a change caused an operating problem and no benefit was gained. Changes should be made based on fundamental understanding of the unit, not on a random basis.
